INVESTIGATION REPORT

GRASSTREE MINE

Incident Number: IN.206200

Incident Title: LW909 TG CH4 >2.5%

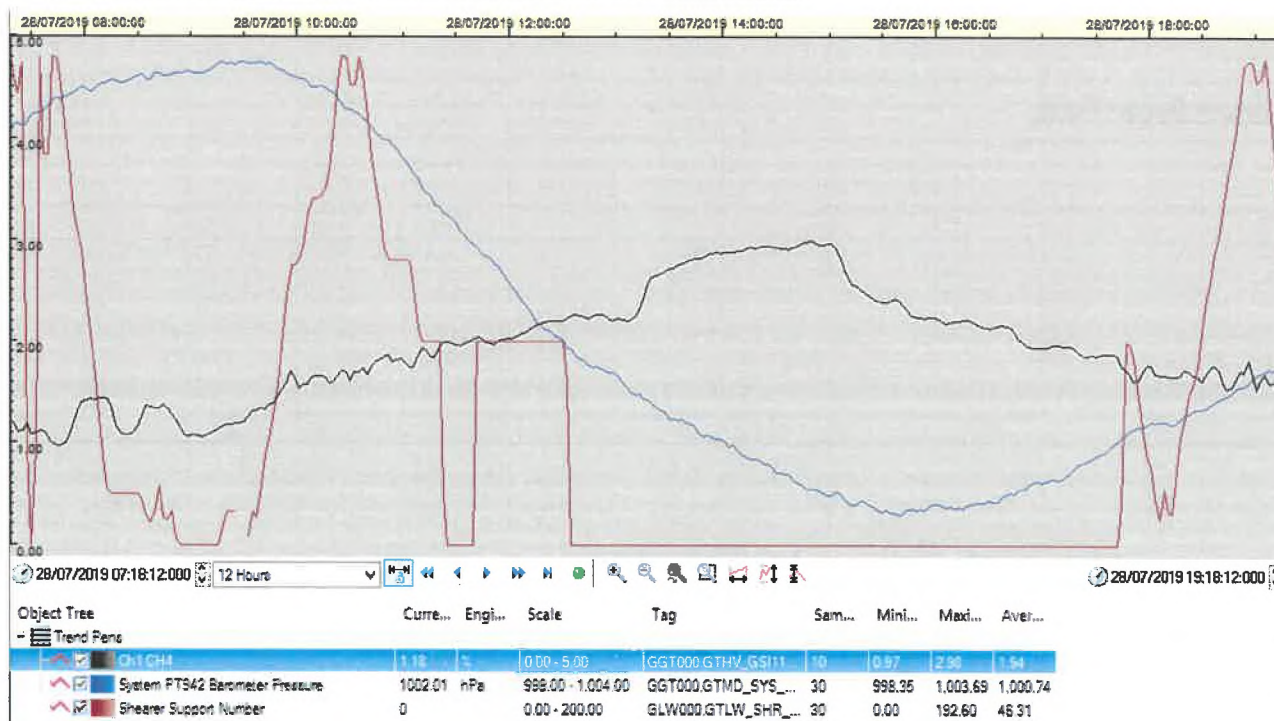
Citect Trend – TG CH4, Barometric Pressure and Shearer Position:

At approximately 09:00hrs on 28th July 2019 the CH₄ concentration in the LW909 tailgate roadway, located outbye the longwall face, began increasing at a steady rate coincident with the falling barometric pressure. The goaf drainage plant and blower were operating at maximum capacity and additional venturi gas extractors were operating. A number of venturi unit were found to be sharing one compressor unit between two venturis.

At approximately 11:00hrs the CH₄ concentration had reached 1.90% and LW coal production ceased and the TG CH₄ concentration continued to rise, reaching a maximum and started levelling off at 2.25% between 12:40 to 12:50hrs. At approximately 13:10hrs there was a sudden rise in the TG CH₄ concentration, reaching 2.5% at 13:15hrs.

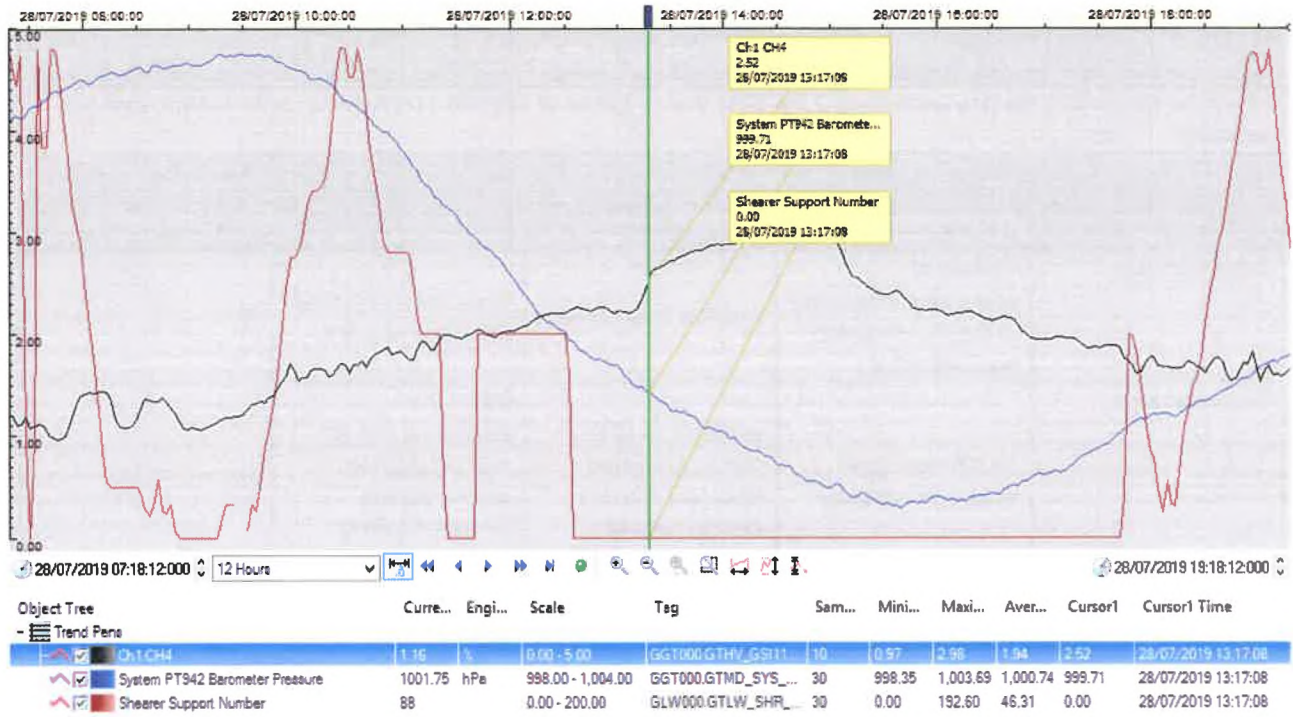
Citect Trend – TG CH4, Barometric Pressure and Shearer Position – time when TG CH4 exceeded 2.5%:

The LW tailgate CH₄ concentration continued to rise and levelled off, reaching a maximum concentration of 2.98% at 14:48hrs.

It is believed that the gas exceedance occurred as a result of a loss of tailgate goaf gas extraction through the failure of the MG908 11ct hammer hole venturi gas extractor caused by a failed radiator hose on the diesel compressor that supplied compressed air to operate that venturi.
