**INVESTIGATION REPORT – SECTION 201  
COAL MINING SAFETY AND HEALTH ACT 1999  
GROSVENOR MINE  
Metallurgical Coal**

**Incident Number: IN.00226742 & IN.00228255**

**Incident Title: Withdrawal from Mine and Ignition of Gas  
LW104**

**Incident Date: 8 June 2020**

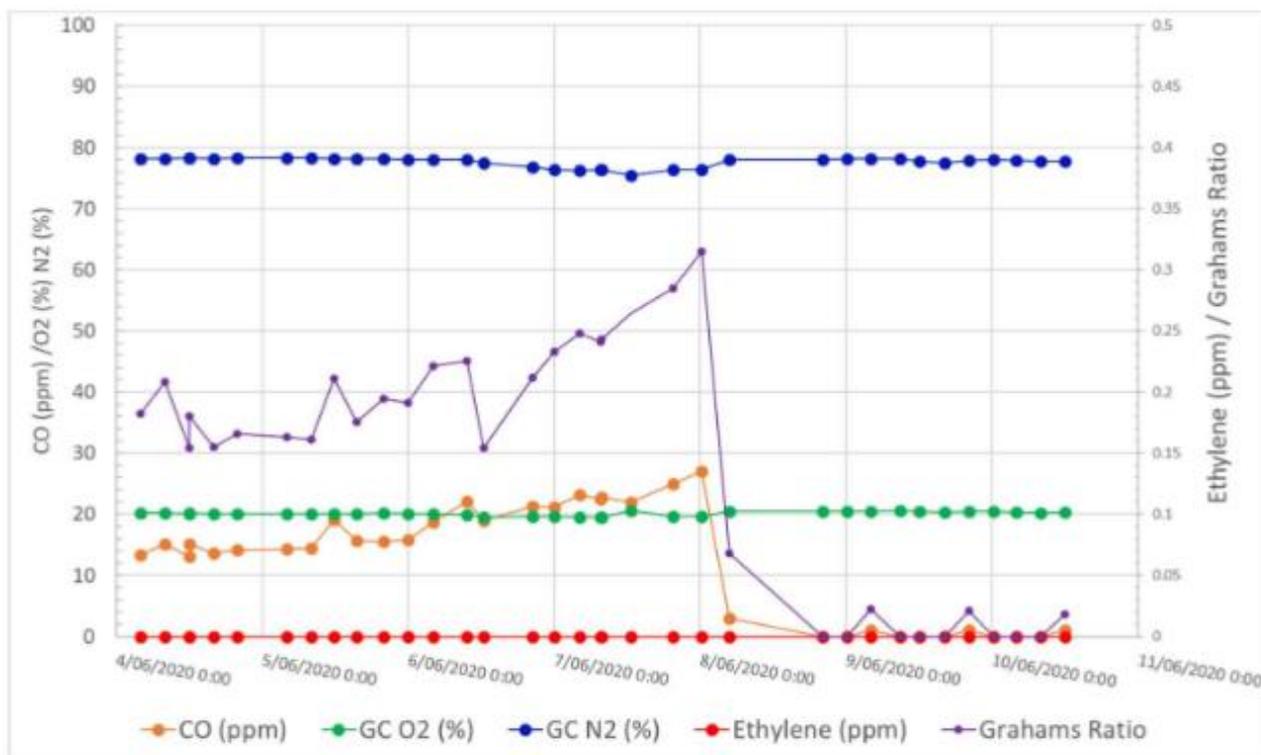
The ventilation change on 8<sup>th</sup> June 2020 was observed to effectively reduce the Graham's Ratio and CO make in the longwall return, as illustrated by the results from TB #26 below.

**Figure 2: TB #26 GC @ TG104 3-4CT B HDG**

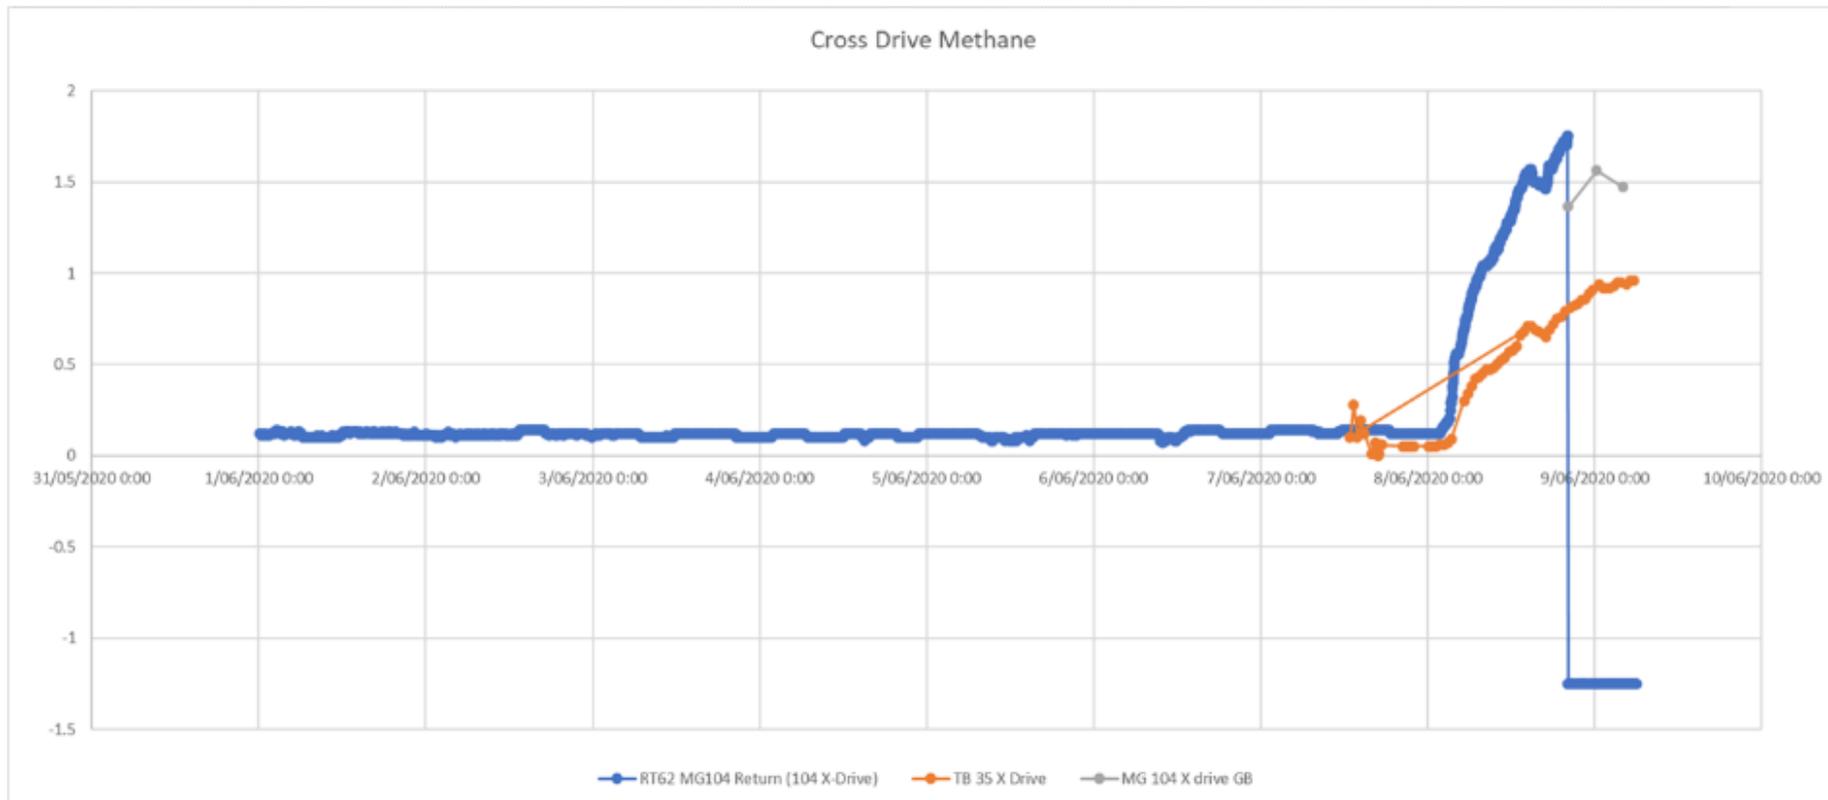
- Increasing methane (**CH<sub>4</sub>**) levels in LW returns;
- Increasing CH<sub>4</sub> levels at real time sensor #62 (LW104 x-drive) (Figures 3-5)
- Vacuum pressure increase identified on tube bundle #36, #40 & #34
- Changes on the shaft 6 pressure sensor (Figure 6)

Figure 3: Cross Drive Methane Levels 1<sup>st</sup> June – 9<sup>th</sup> June 2020

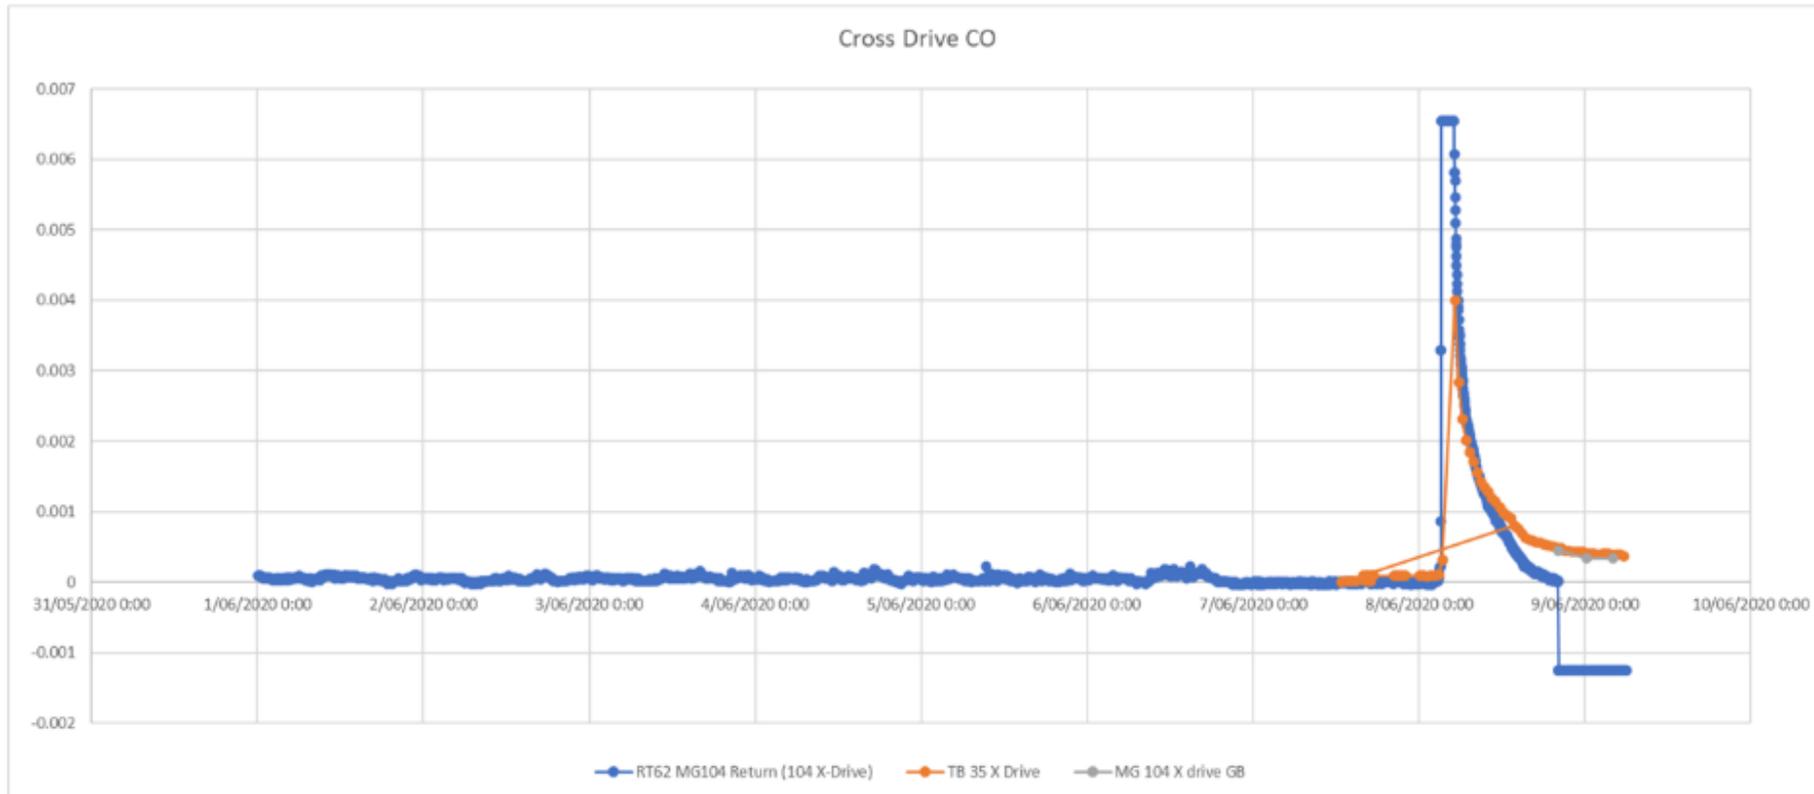
Figure 4: Cross Drive Carbon Monoxide Levels 1<sup>st</sup> June – 9<sup>th</sup> June 2020

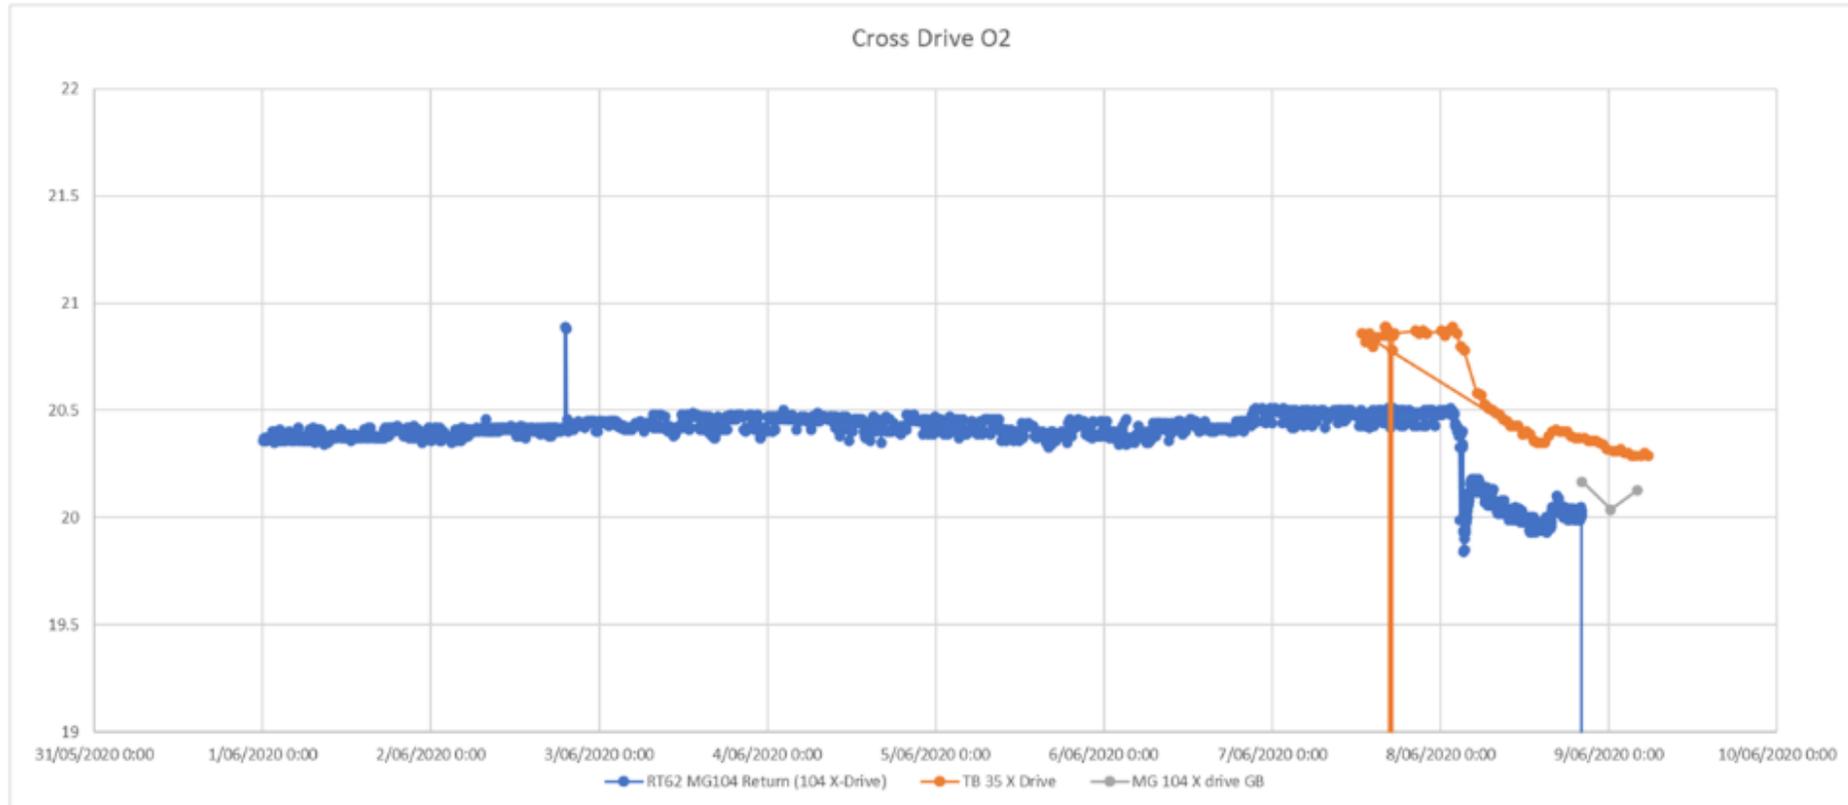
Figure 5: Cross Drive Oxygen Levels 1<sup>st</sup> June – 9<sup>th</sup> June 2020

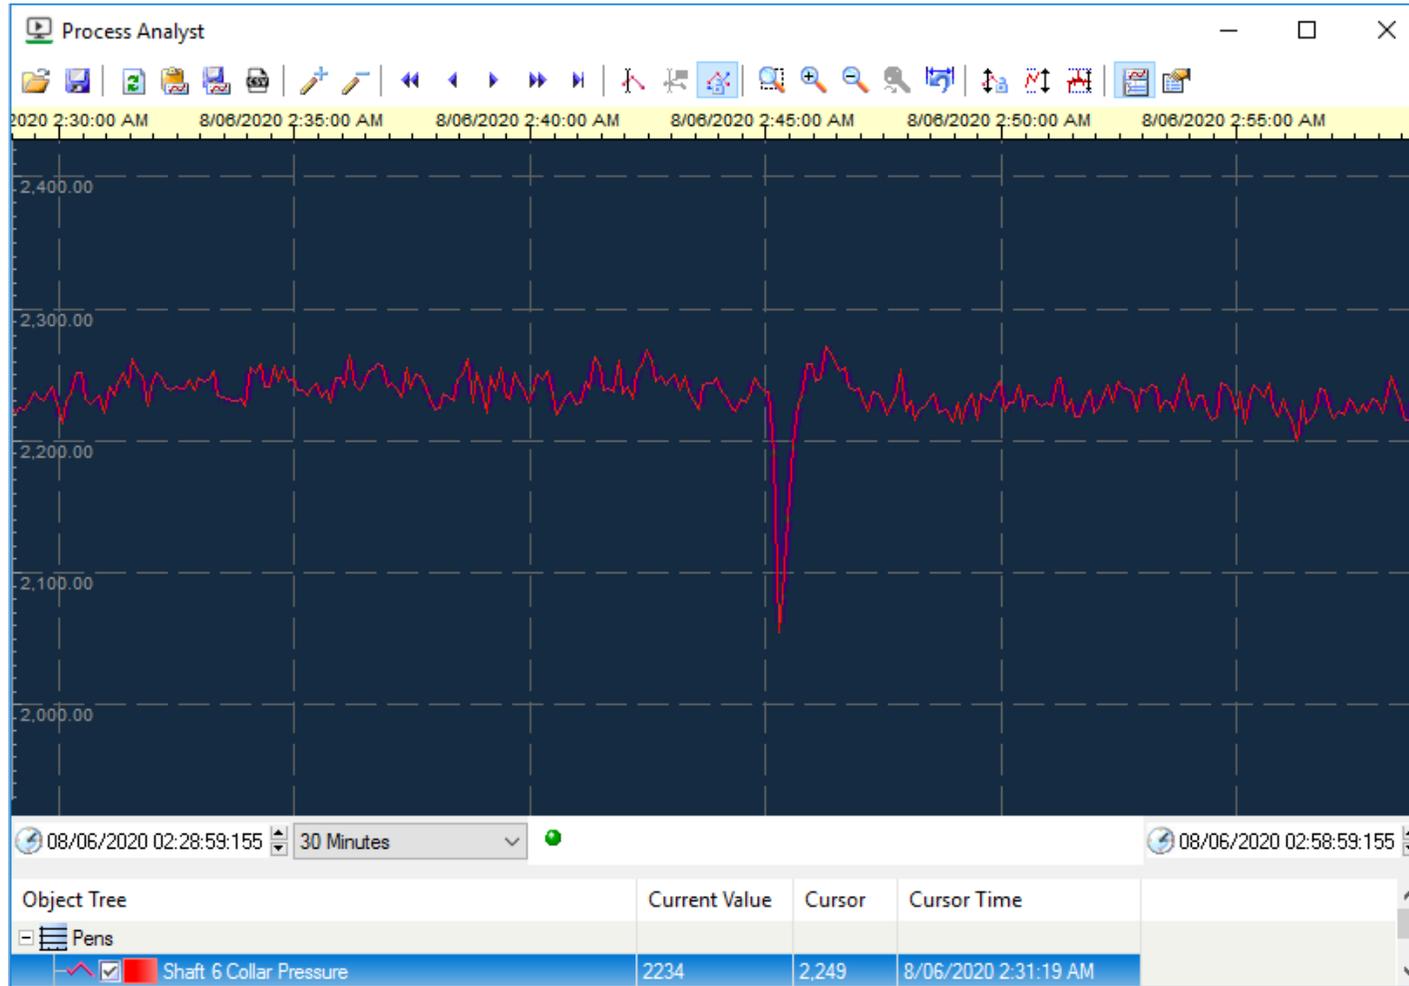
These observations suggested that an overpressure event had likely occurred between 2:45am and 3:00am on Monday 8<sup>th</sup> June.

Figure 6: Shaft 6 Collar Pressure 8<sup>th</sup> June 2020

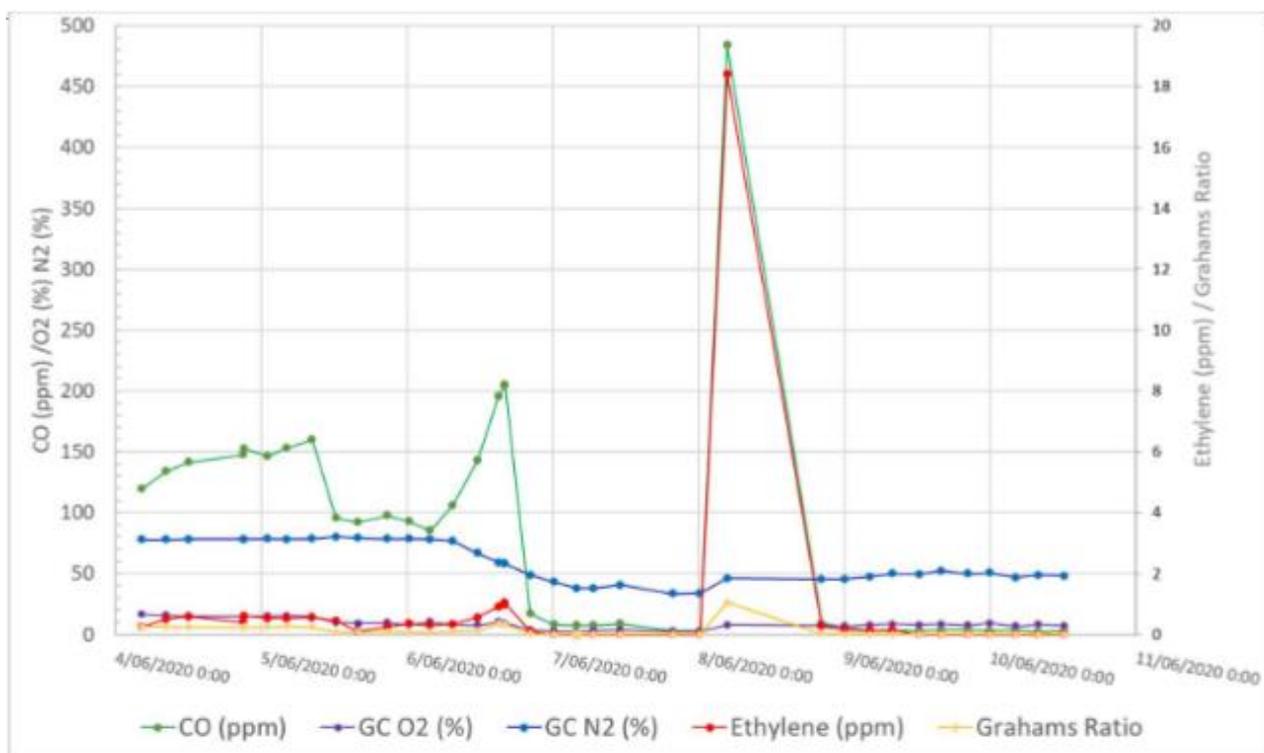
Further analysis of the Tube Bundle system identified that the overpressure may also have been an ignition of gas. This was determined by the Ethylene and CO concentrations detected at the tailgate C-Hdg stopping between 36 and 37c/t (Figure 7).

**Figure 7: TB #13 GC @ TG104 36-37CT C HDG STOPPING**

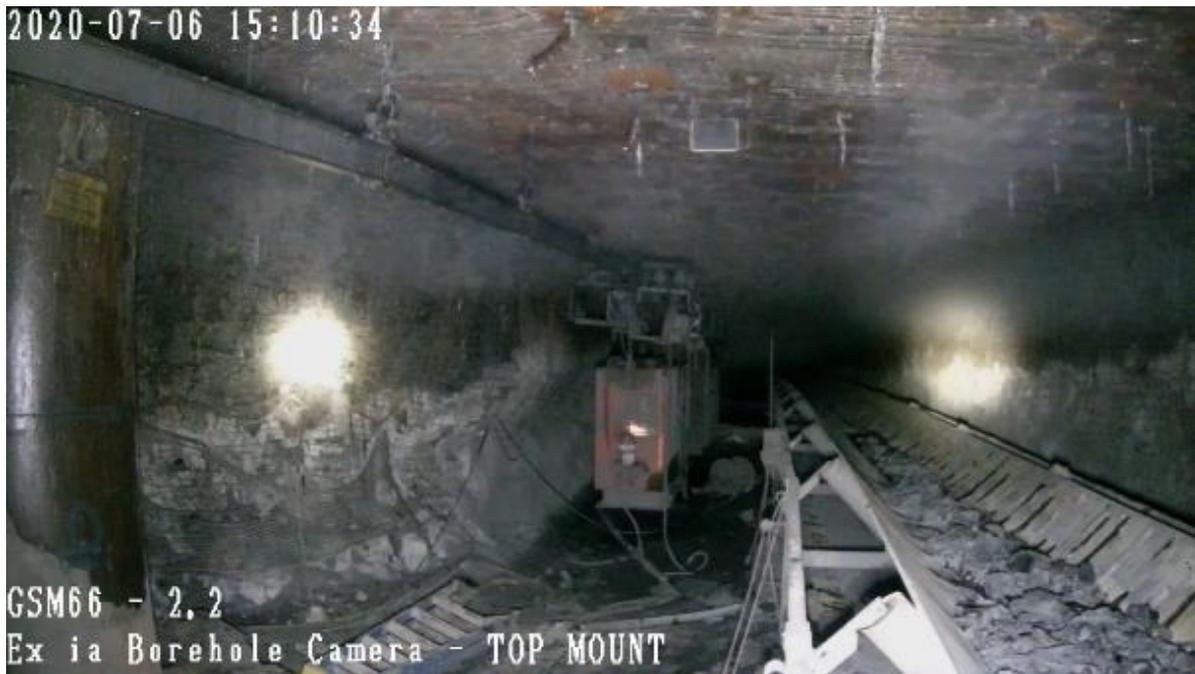
Figure 8: MG104 "C" heading 34-35c/t (looking outbye)

A camera was subsequently deployed from the surface into the underground workings via a borehole. The footage captured did not provide any firm evidence of an ignition having occurred, with no signs of heat or flame path (Figure 8 and 9). It did however support the occurrence of an overpressure event, with damage observed to the flexi stopping at 36c/t in MG104 that had been built prior to withdrawal of persons from the mine (Figure 10). This is also the likely cause of the loss of monitoring at several of the tube bundles, which were likely damaged as a result of the overpressure event.

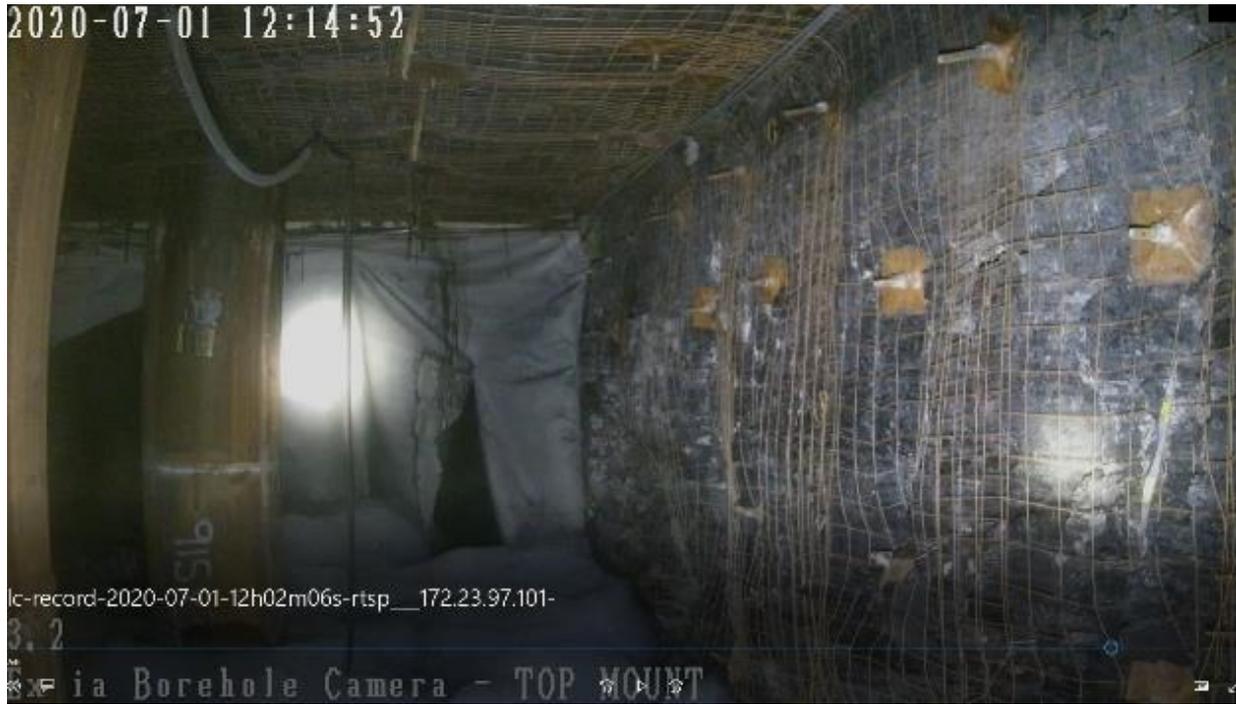
**Figure 10: Flexi Stopping at 36 c/t in MG104**

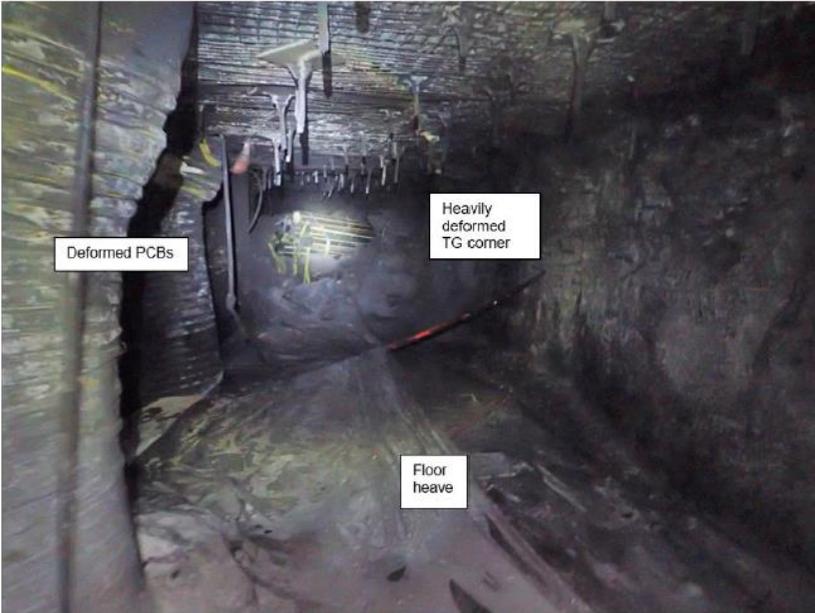
16 <sup>th</sup> May 2020	<p>Strata Risk Management Team formed due to deteriorating conditions in the TG roadway, triggering Level 2 LW Strata Control TARP. Notes on TG conditions (and photos from minutes):</p> <ul style="list-style-type: none"> <li>• Rill material located adjacent the TG shield is restricting access to the TG. Pipes set up adjacent to rill material</li> <li>• The TG corner is heavily deformed and broken</li> </ul>

<p data-bbox="510 963 949 986">Figure 2: TG looking inbye from ~10m outbye face</p> </div> <div style="text-align: center;">

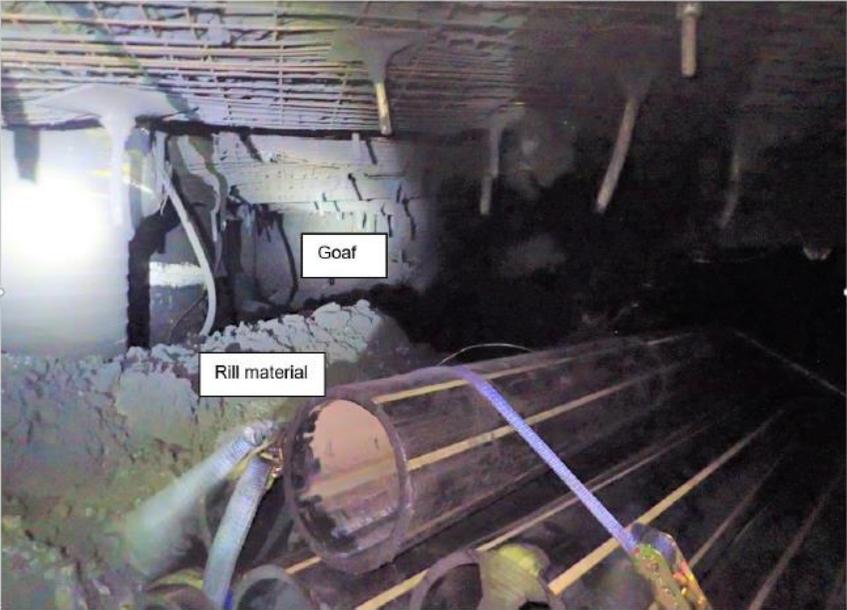
<p data-bbox="1344 957 1809 979">Figure 3: TG looking inbye at the goaf from TG face</p> </div> </div>

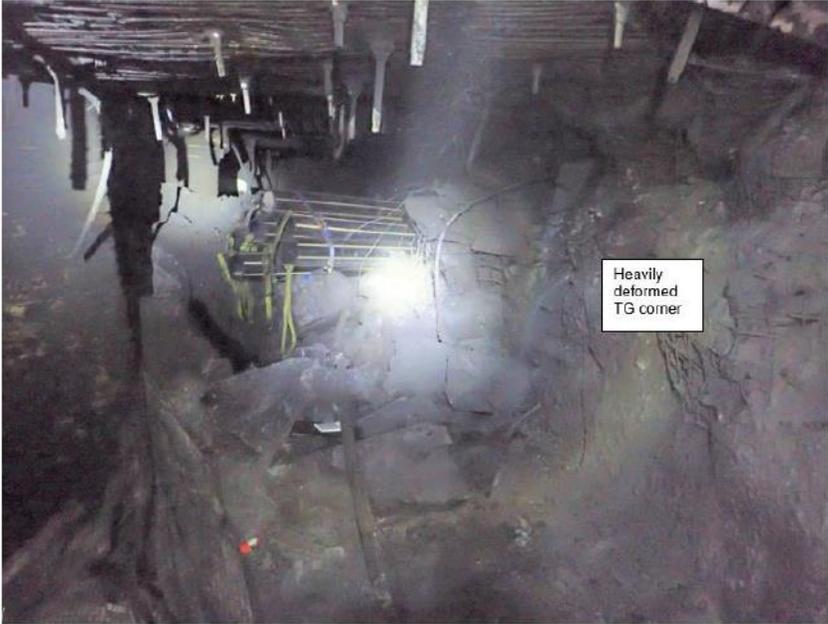
<p data-bbox="535 968 931 991">Figure 4: TG looking inbye from ~5m outbye</p> </div> <div style="text-align: center;">

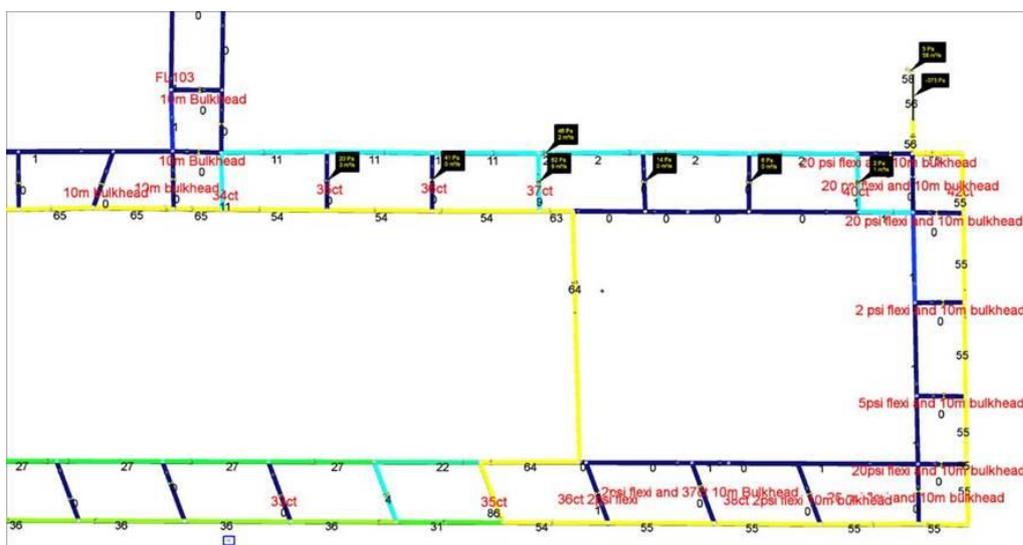
Ventsim model suggests around 50Pa-70Pa differential pressure on the TG104 C36-C37 stopping (based on the ventilation quantities in and around the LW circuit on the 6th of June). This takes into account modelling the ventilation control device in 40c/t damaged (with minimal resistance) and a brattice substantial stopping installed at C36-C37. 50Pa-70Pa pressure for a 3.7 metre by 5.4 metre roadway equates to around 100-140kg of force against the stopping. This would not be deemed to be excessive for a substantial brattice stopping constructed as per the installation permit (with snap jacks, mesh, ratchet straps etc).

**Figure 11: Ventsim Model simulated as of 2<sup>nd</sup> June 2020**

This data challenges whether the impact of the damage / deterioration in one (at least) of the VCD's in the inbye cut throughs in the TG was adequately assessed and controlled accordingly. Given the original SOP was reliant on at least 14kPa rated VCDs in the cut throughs to be maintained, the use of a substantial brattice stopping in C heading was a change from the intent of the LW104 TG ventilation system

The above considered, it is recommended that in future, a higher level of control be applied when designing the ventilation system with dual returns within a Longwall Tailgate roadway, to prepare for extenuating circumstances such as that experienced at Grosvenor. That is, to install standard seals around the perimeter of the longwall, with passive support provided to ensure they maintain integrity as the longwall retreats.

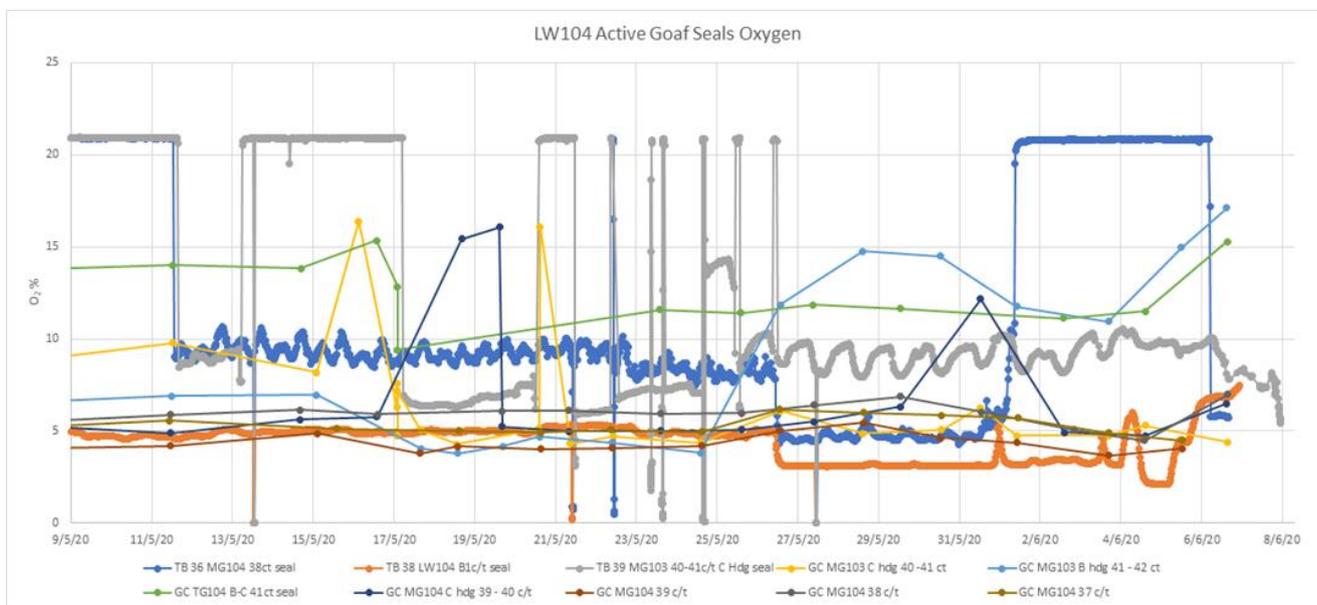
Figure 12: LW104 Active Goaf Seals Oxygen

Note that despite inertisation being injected into the majority of these seals, the oxygen levels at the inbye seals (closest proximity to the downcast shaft and highest differential pressure and risk of oxygen ingress), shows that the impacts of Nitrogen injection appear limited. For example, MG103 41c/t B-C heading seal had around 14% oxygen up to around the 17th of May before then being maintained at around 11% oxygen thereafter.

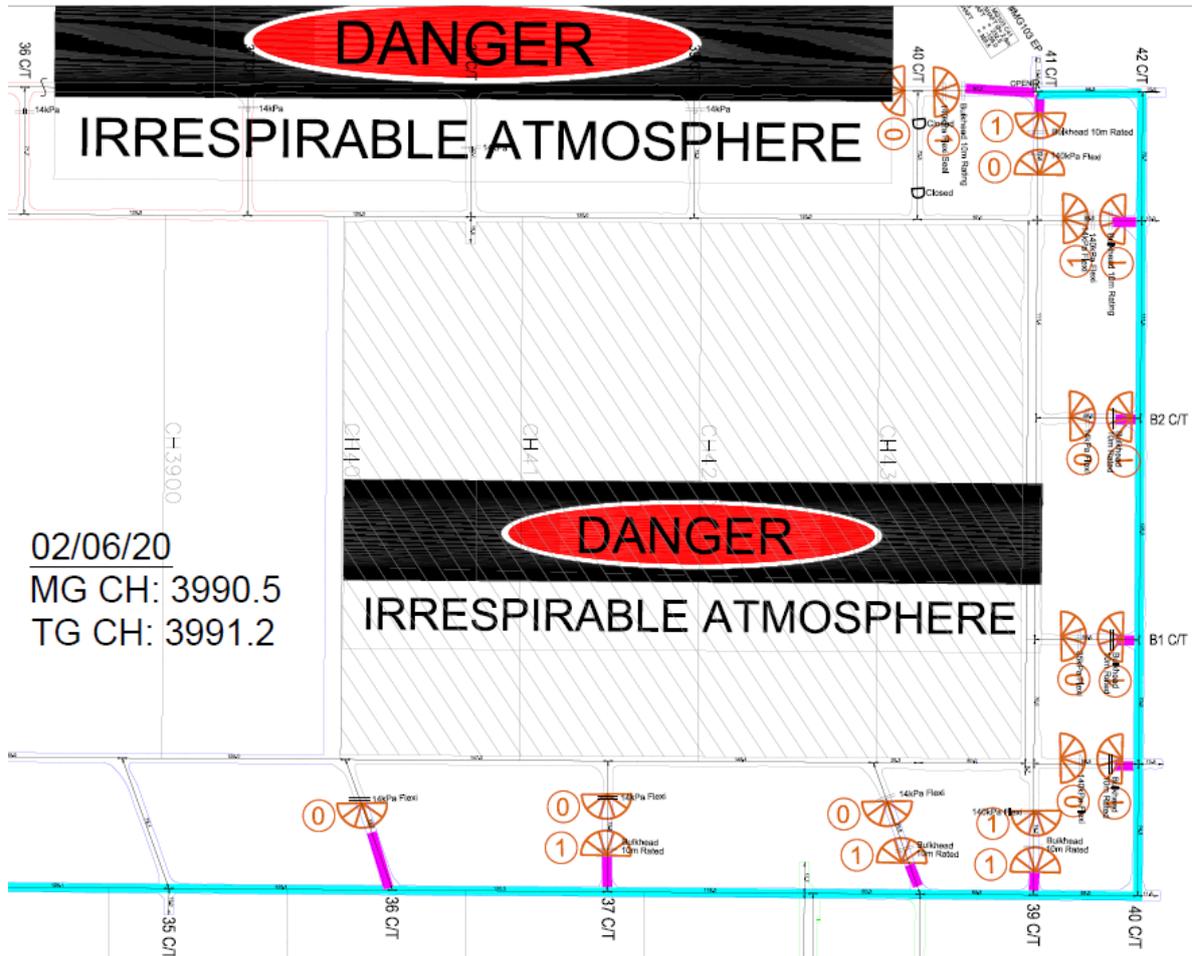
The inertisation pipework / layout as of 2<sup>nd</sup> of June in the LW104 perimeter (before any changes made during the Level 2 TARP trigger events from 2<sup>nd</sup> of June onwards as per IMT directions) was as per Figure 13 below.

Figure 13: Inertisation Pipework / Layout as at 2<sup>nd</sup> June 2020

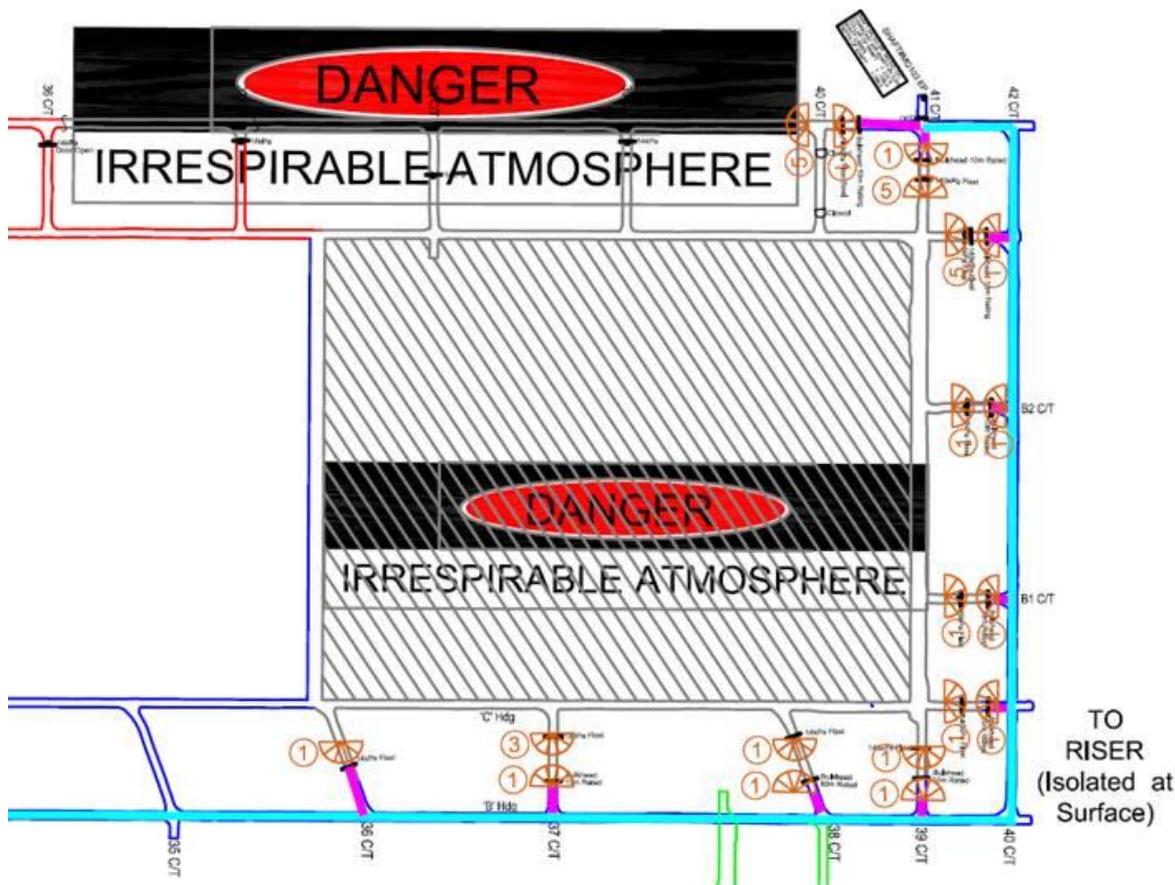
Figure 14: Inertisation Pipework / Layout as at 23<sup>rd</sup> June 2020

Despite two Floxal (Nitrogen) plants running at full capacity into the UG Workings it now appears that a large portion of this Nitrogen was being injected into the adjacent LW103 goaf, with little Nitrogen making it to the inbye end of the LW104 perimeter pipe range and in turn into the goaf through the seals closer to shaft 9 (with the highest differential pressure across them).

It appears that the UG Nitrogen injection reticulation system did not provide adequate flow to the inbye seals of the LW panels in the current configuration. Further investigation highlights lack of flow meters installed to identify the flow into each gateroad / LW panel. It is recommended to develop a Nitrogen (inertisation) strategy / procedure that adequately captures the required design and monitoring parameters so sufficient flow is available to meet the intended purpose of the inertisation chambers behind the goaf seals and in turn, reduce the oxygen ingress and spontaneous combustion risk.
