INVESTIGATION REPORT

GRASSTREE MINE

Incident Title: >2.5% CH₄ LW808 #197

Report Date: 22/04/20

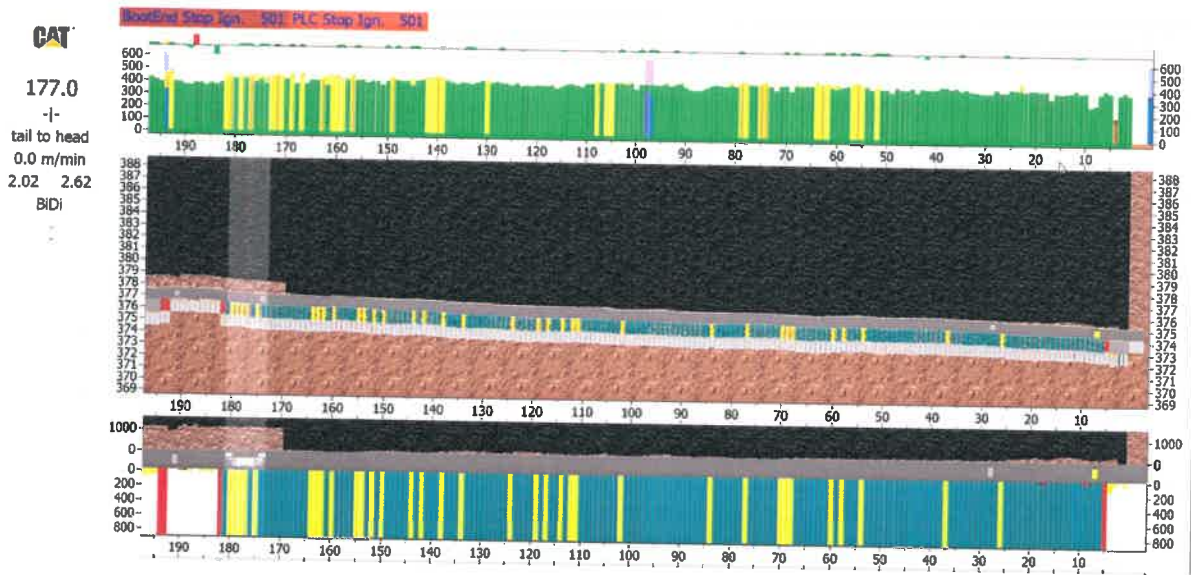
Figure 53. Shearer and Shield Position at Time of HPI (IN.00223278)

11/04/20 04:00		ERZ C (L Shackleton) removes Sherwood Curtain
11/04/20 21:10		DS hand over to AS on face. ERZ C Noted flaps installed on #194, 195 as per Vent Advice #03-20. Also observed #197 ~300mm higher in roadway
11/04/20 21:25	Incident	LW808 Shearer cuts into TG and starts to cut back towards MG out to snake. Shearer at #177 SRB is on and chocks 193-181 advance in automation and face trip event occurs when "0m CH4 Sensor" >2%, peaking at 4.18% for a period of 56min 25 seconds.
11/04/20 Post Event	After the Incident	ERZ C Notifies MSO of event.
11/04/20 Post Event		Sherwood curtain erected
11/04/20 Post Event		VO investigates following day and determines excessive goaf gas reaching #197 from #196 due to mis-matched canopy attitude.

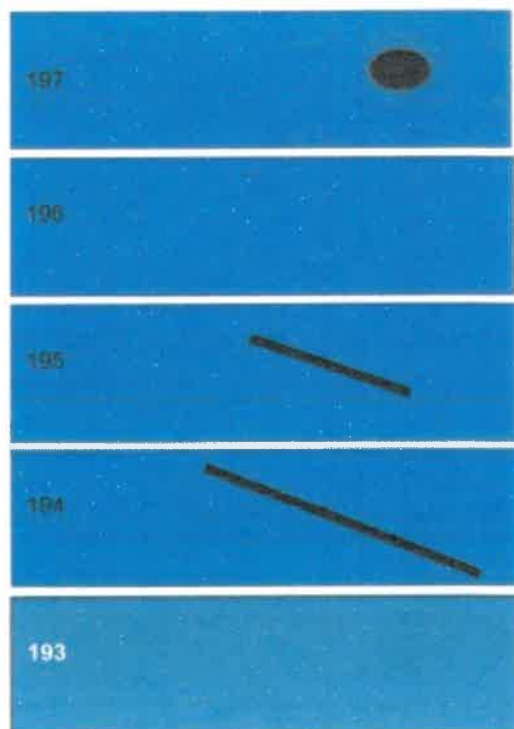
To assist ERZCs in management of the ventilation arrangement around the 0m sensor, flaps have been installed on chock 194 and 195 to assist in pushing the goaf fringe further back into the active goaf as a trial.

Flaps approx. 10mm thick
 195 shield flap to be approx. 1m in length running at 40-45 degrees
 194 shield flap to be approx 2m in length again running at 40-45 degrees

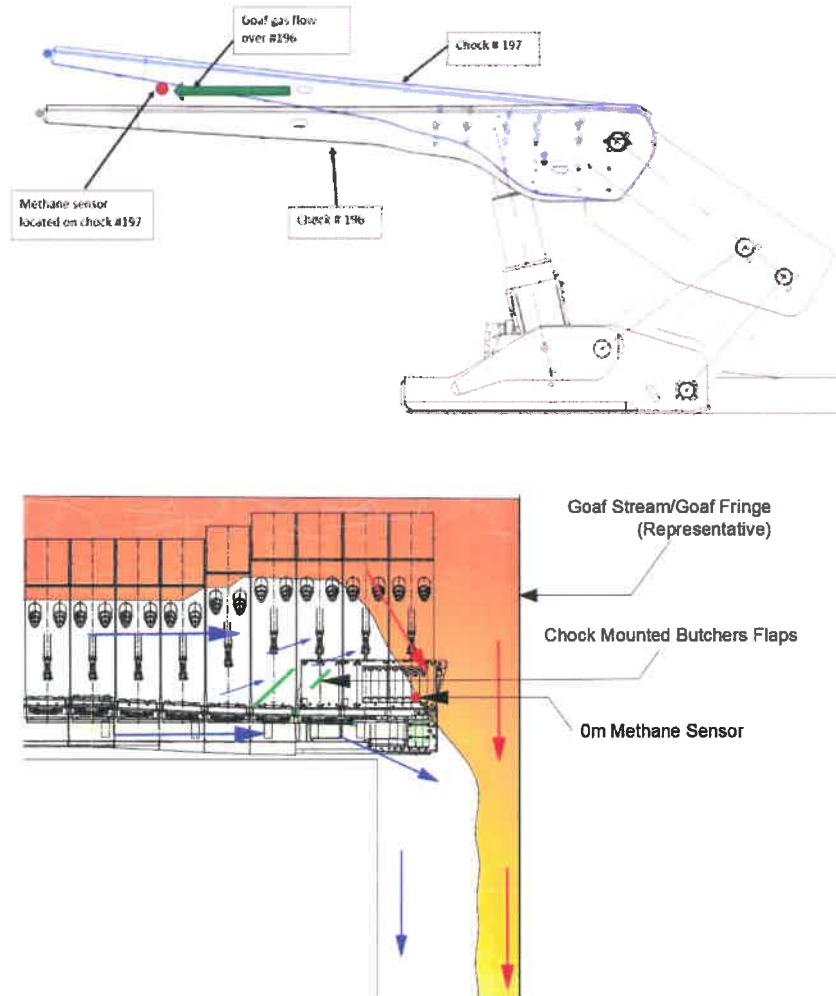
Figure 67. Representation of goaf gas reporting to sensor when #197 chock attitude 300mm higher than adjacent chock

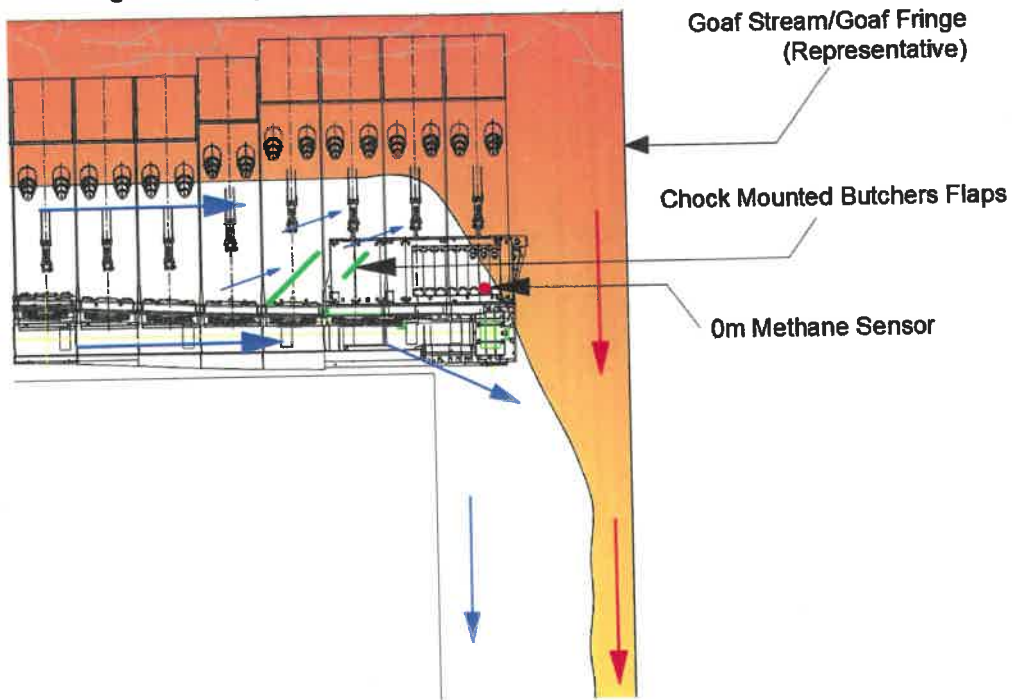
Figure 69. Representation of Goaf stream relative to sensor when high production of goaf drainage fails

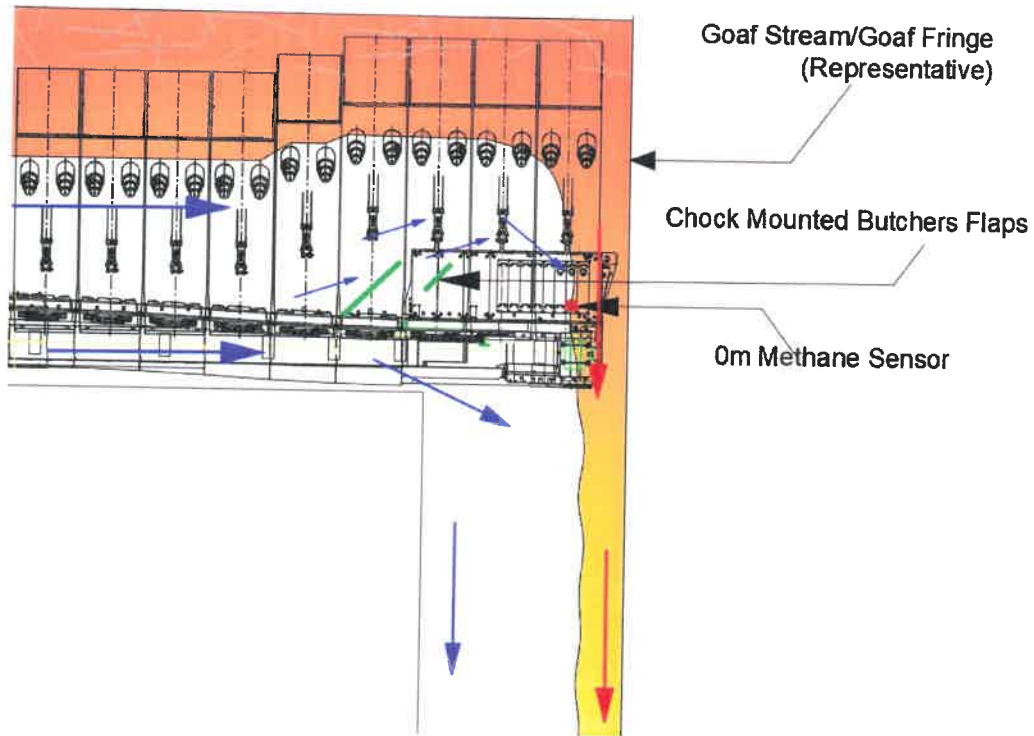
Figure 70. Representation of Goaf stream relative to sensor when roadway/face alignment is poor

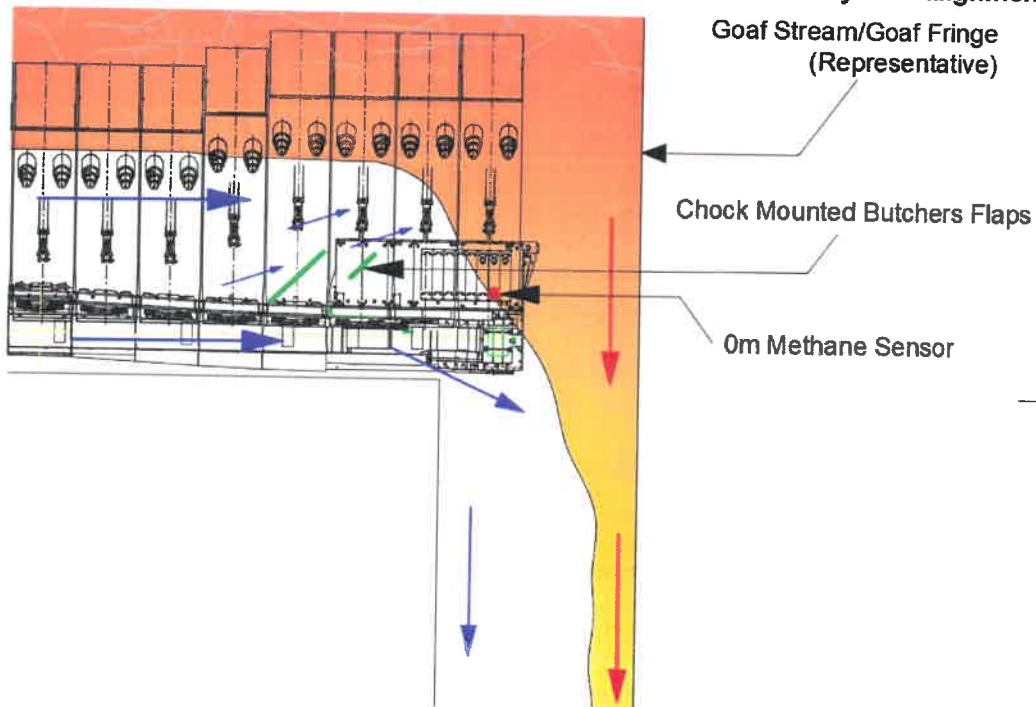
Figure 71. Representation of Goaf stream relative to sensor when shearer wash/chock advance forces goaf gas out

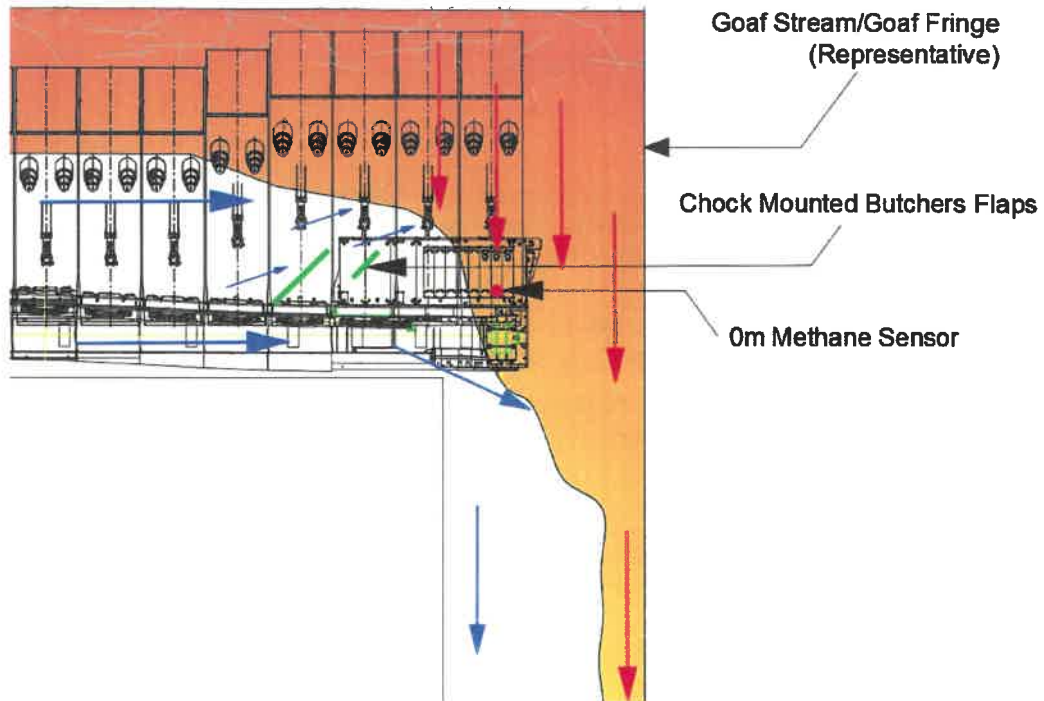
Figure 72. Representation of Goaf stream relative to sensor when goaf fall event occurs
