LEARNING FROM INCIDENTS

INVESTIGATION REPORT

MORANBAH NORTH MINE

Incident Title: Methane exceedance in TG of LW604

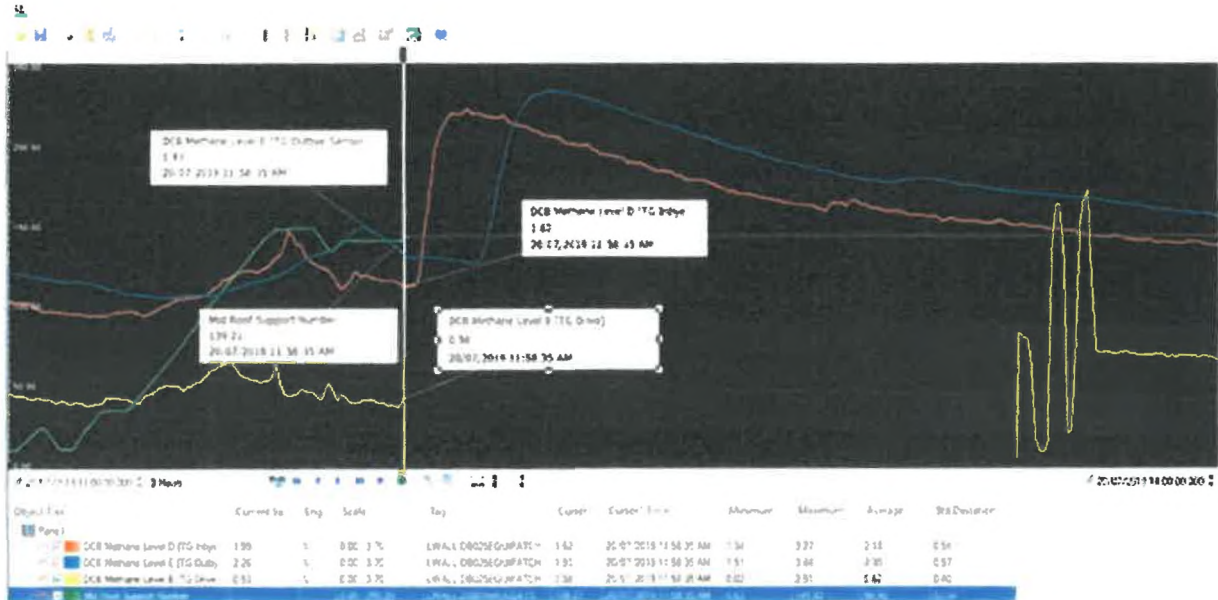
1. Shearer @ #140 shield - start to rise CH₄ at TG Inbye sensor

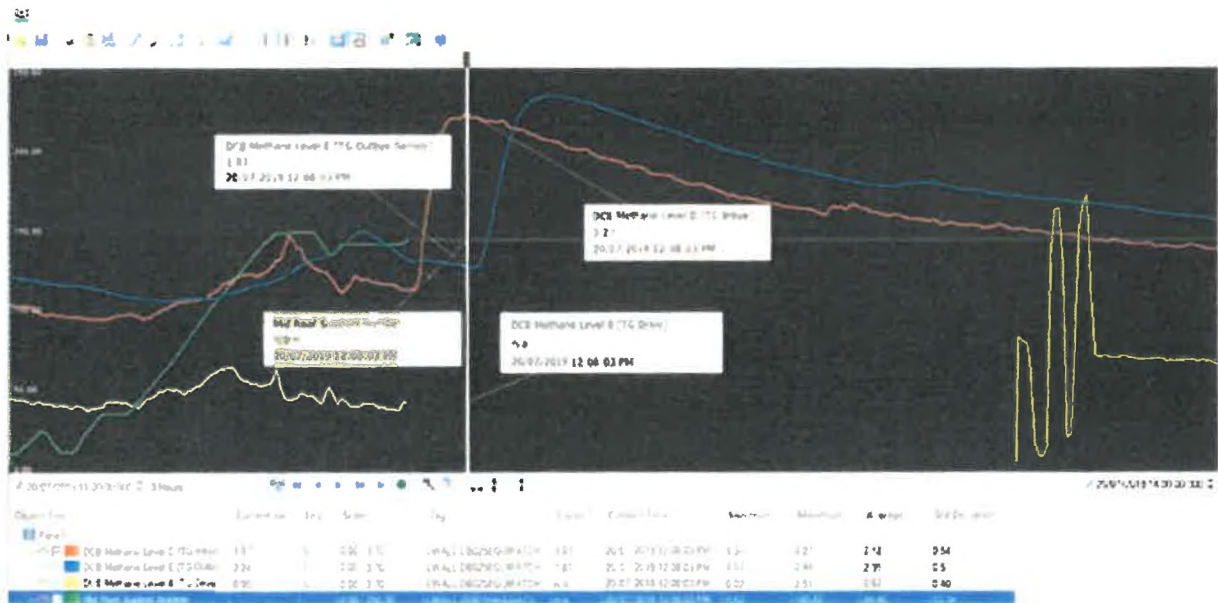
1. Max CH₄ - TG inbye sensor

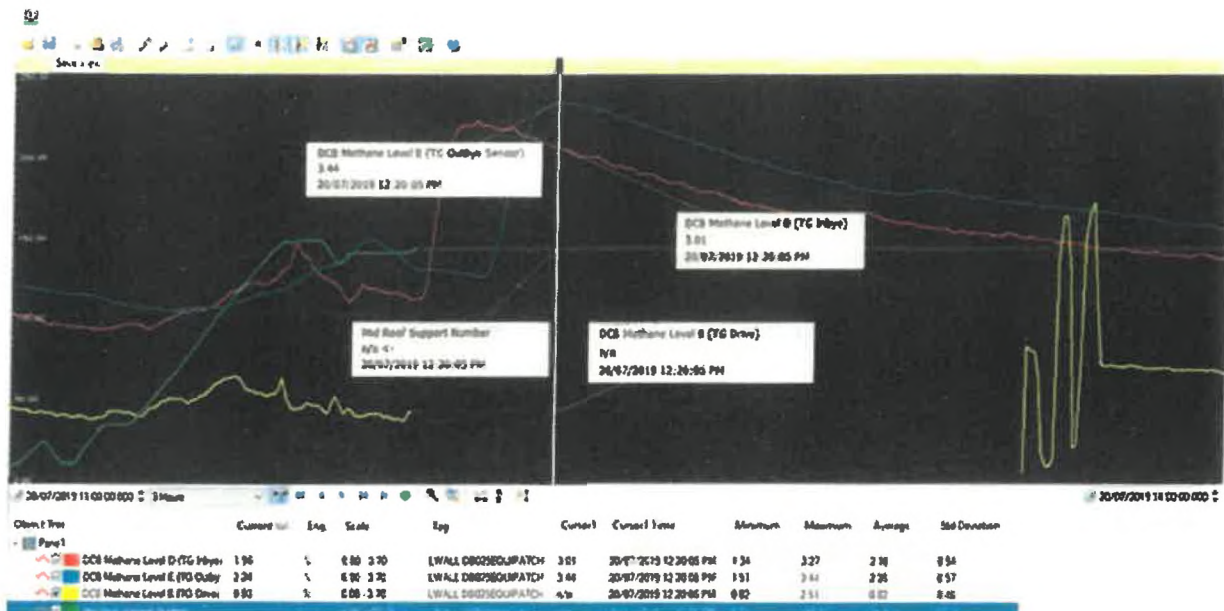
Leading up to the time of the event CH₄ level in the TG roadway was between 1.6% and 2%. At 12:12pm the TG outbye sensor passed 2.5% CH₄, peaking at 12:22pm at a GB concentration of 3.36% CH₄ and did not drop below 2.5% until 1:25pm. SO670A was the closest goaf drainage well but was in standby mode due to low methane and high oxygen (O₂).

1. Max CH₄ - TG outbye sensor
