| Mine Name | Mine ID | Operator | Activity Type | Activity Date |
|---|---|---|---|---|
| Grosvenor Coal Mine | MI02976 | Anglo Coal (Grosvenor Management) Pty Ltd | Inspection | 02/07/2019 |

Mine Record Entry

Today the 2nd July 2019 Department of Natural Resources Mines and Energy Inspector Keith Brennan travelled to Grosvenor Underground operations, the focus of my inspection was 103 Longwall gas exceedances and familiarisation of the introduction of iPads for recording Statutory Inspections.

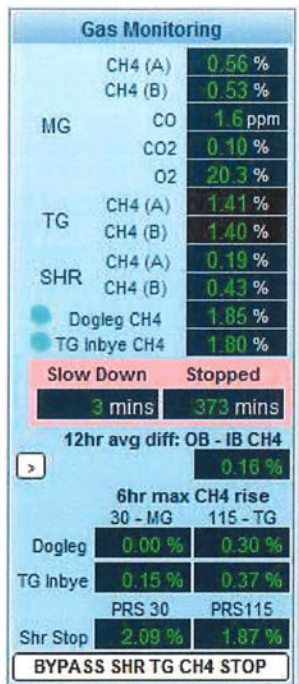
Bi-Di cutting sequence - Shearer cuts to towards tailgate a value calculated using the difference between the inbye and outbye readings - the value displayed by the tailgate 1.8%CH₄ real time monitor.

The accompanying screen shot indicates 1.80% CH₄ was present at the inbye tailgate sensor the shearer would cut to 115# - 1.87% CH₄ was detected/displayed the shearer would cease cutting and park at 115# until gas levels fall below 1.80% CH₄, this value changes each shear depending on previous gas variations between inbye and out tailgate sensors.

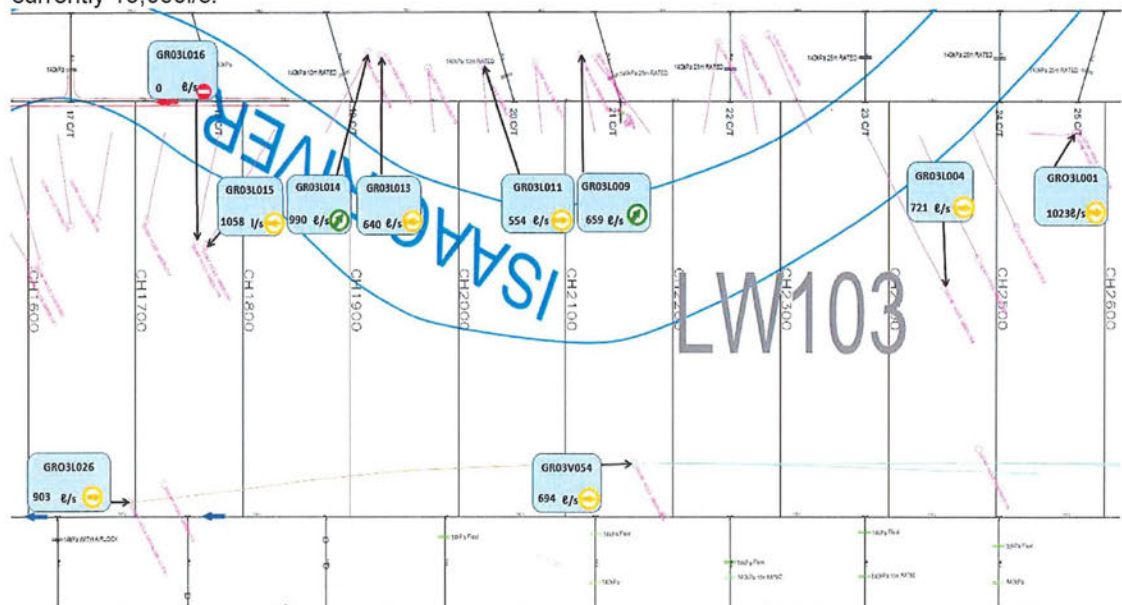
Lateral gas drainage hole GRO3L016 located at 1760 chainage is due to come on line. The hole has been drilled laterally due to the location of the Isaac River. Gas drainage capacity currently 10,000l/s.
