INVESTIGATION REPORT

GRASSTREE MINE

Incident Number: IN.00219432

Incident Title: >2.5% CH4 LW808 #197

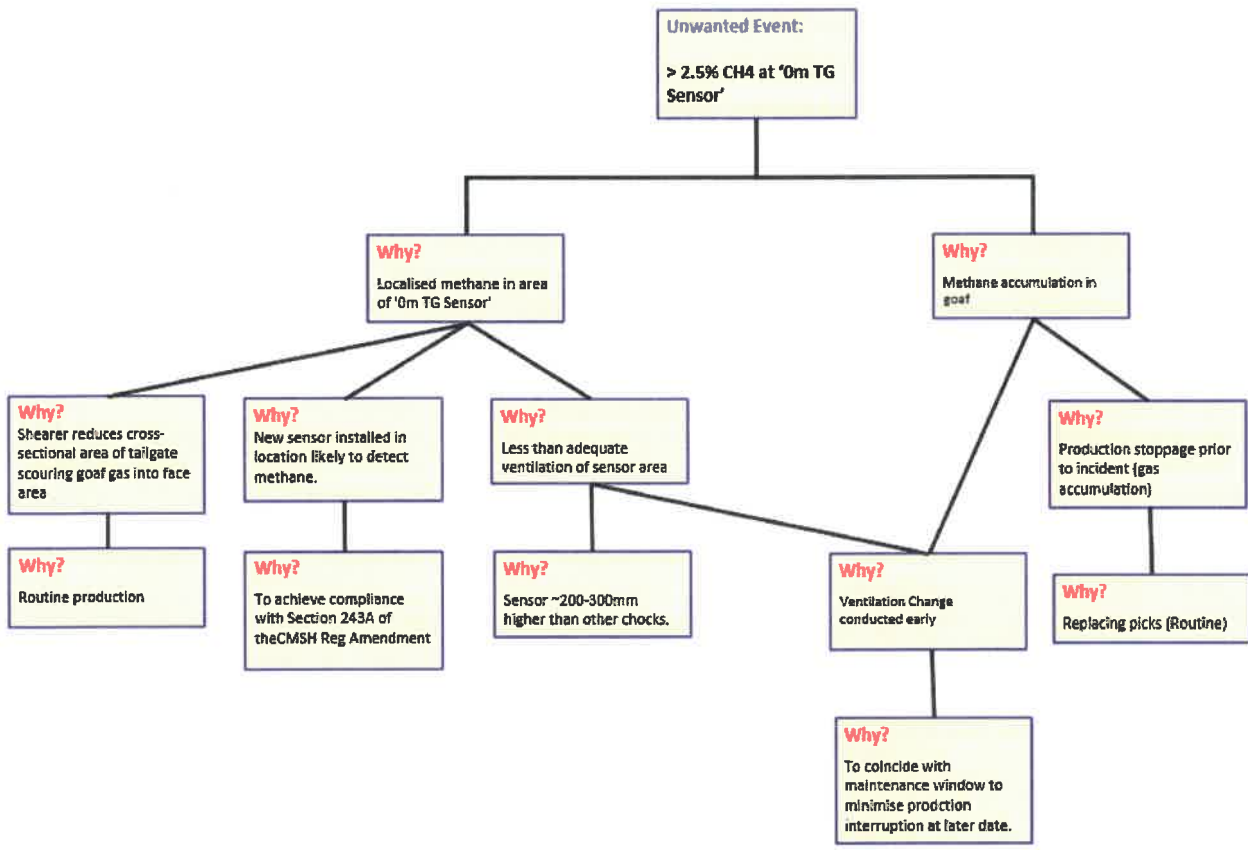
Figure 1. IN.00219432 Anglo LFI Tool Why Analysis

This incident occurred due to localized elevated methane in the vicinity of the '0m TG Sensor' during normal production.

- Location of a new sensor on TG chock canopy, being a position where methane is more likely to be detected being both at the tailgate end of the face (where goaf gasses are most likely to be drawn into the airstream) and high (where methane is most likely to layer due to a low relative density).

- The canopy of #197 being ~200-300mm higher than the adjacent chock due to a disparity between the cut face and the TG roadway height, again making the '0m TG Sensor' in position of higher sensitivity to methane.

- Implementation of the routine longwall retreat ventilation change earlier than usual (reducing pressure on the goaf which in turn increased the potential for goaf gases to migrate into the roadway)

- A brief production cessation to replace picks may have allowed for an accumulation of methane to occur in the tailgate goaf area, which was subsequently disturbed by the increased air velocity in the tailgate caused by the reduction in cross-sectional area as the shearer cut into the tailgate.

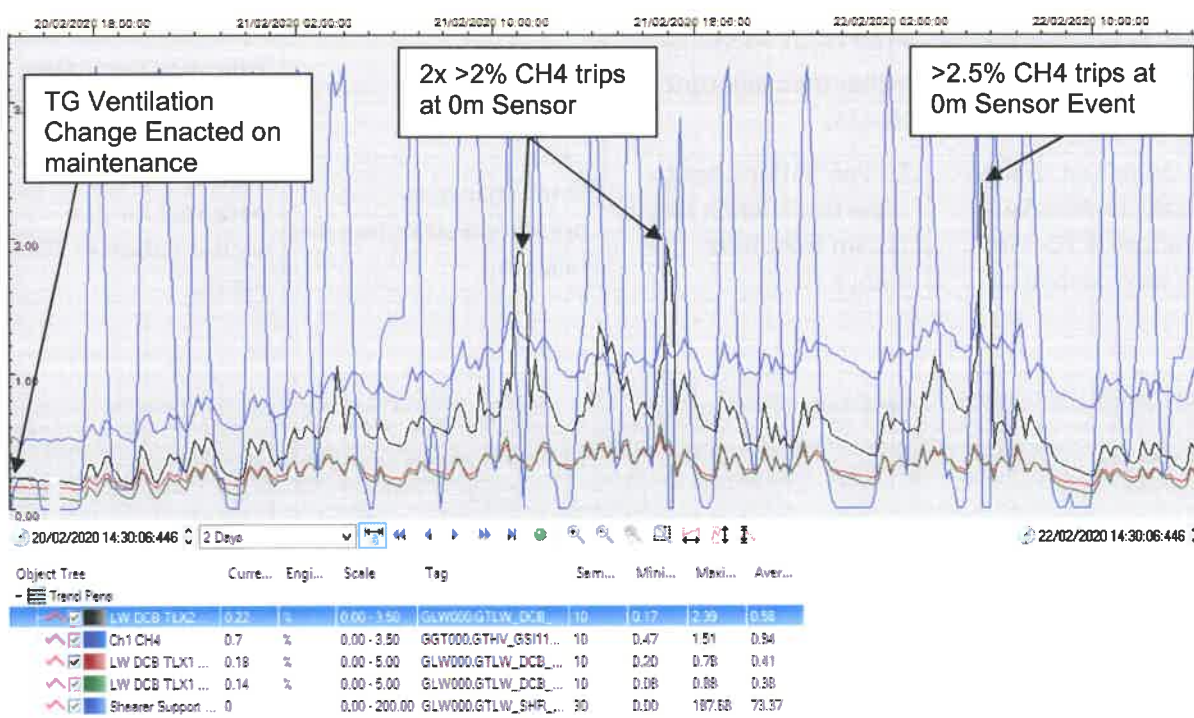
Figure 3. Shearer and CH4 monitor trending over 2 days including >2.5% CH4 trip event and two preceding >2% trip events on the day prior to the incident.

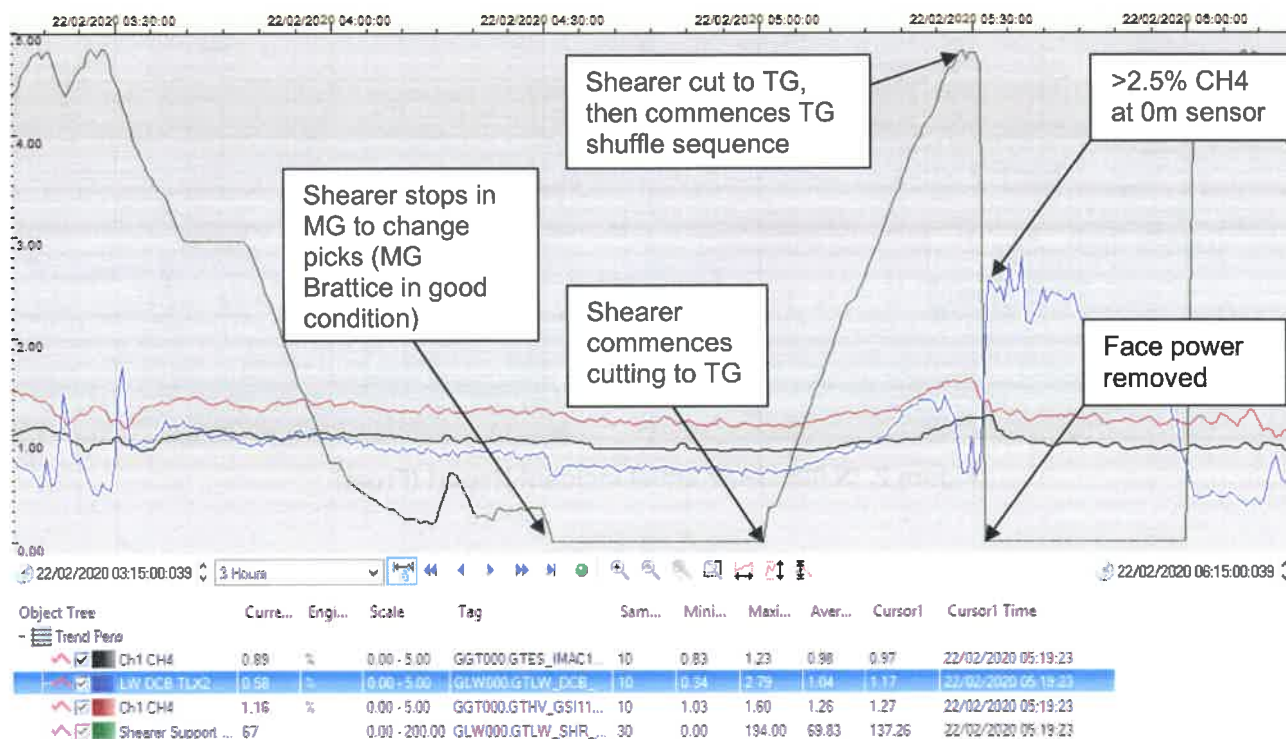
Figure 4. Shearer and CH4 monitor trending showing timescale of incident from shearer entering maingate of picks, then cutting to TG, and power trip event

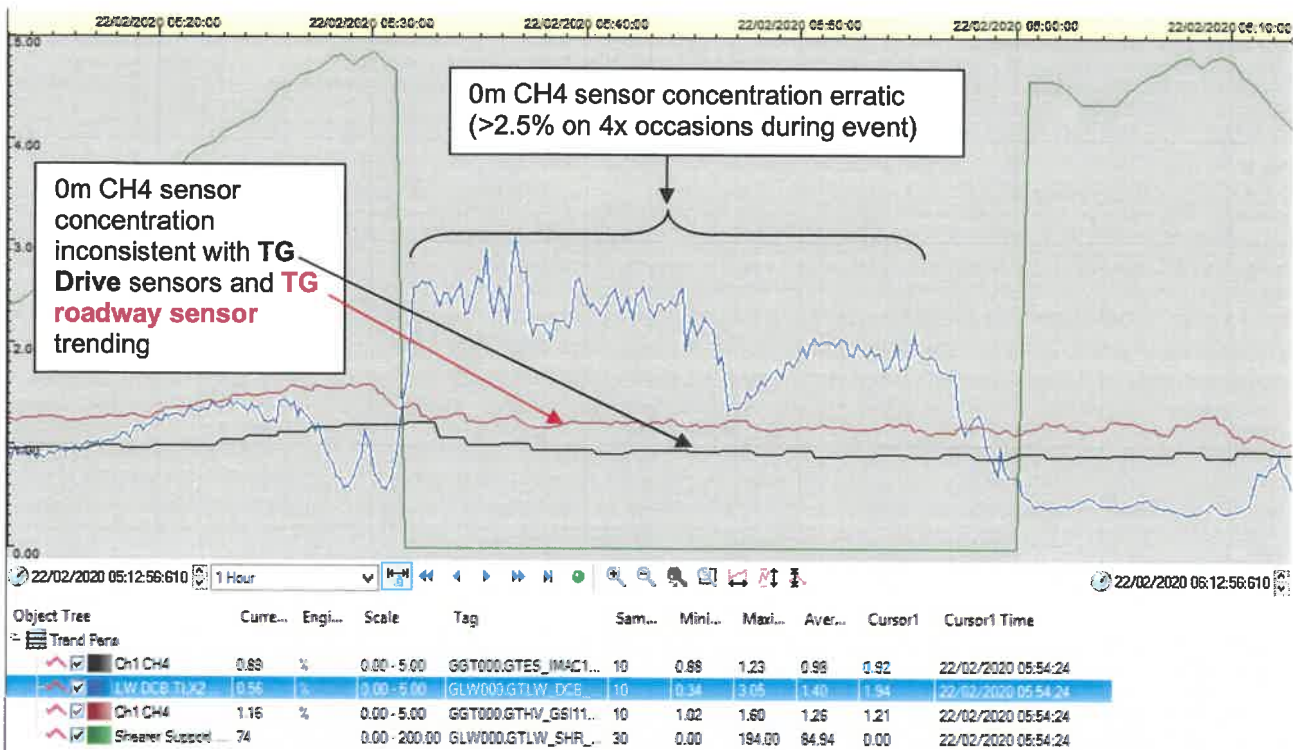
Figure 5. Shearer and CH4 monitor trending showing 0m Sensor CH4 concentrations escalating after shearer exit from maingate and erratic variation inconsistent with nearby sensors.

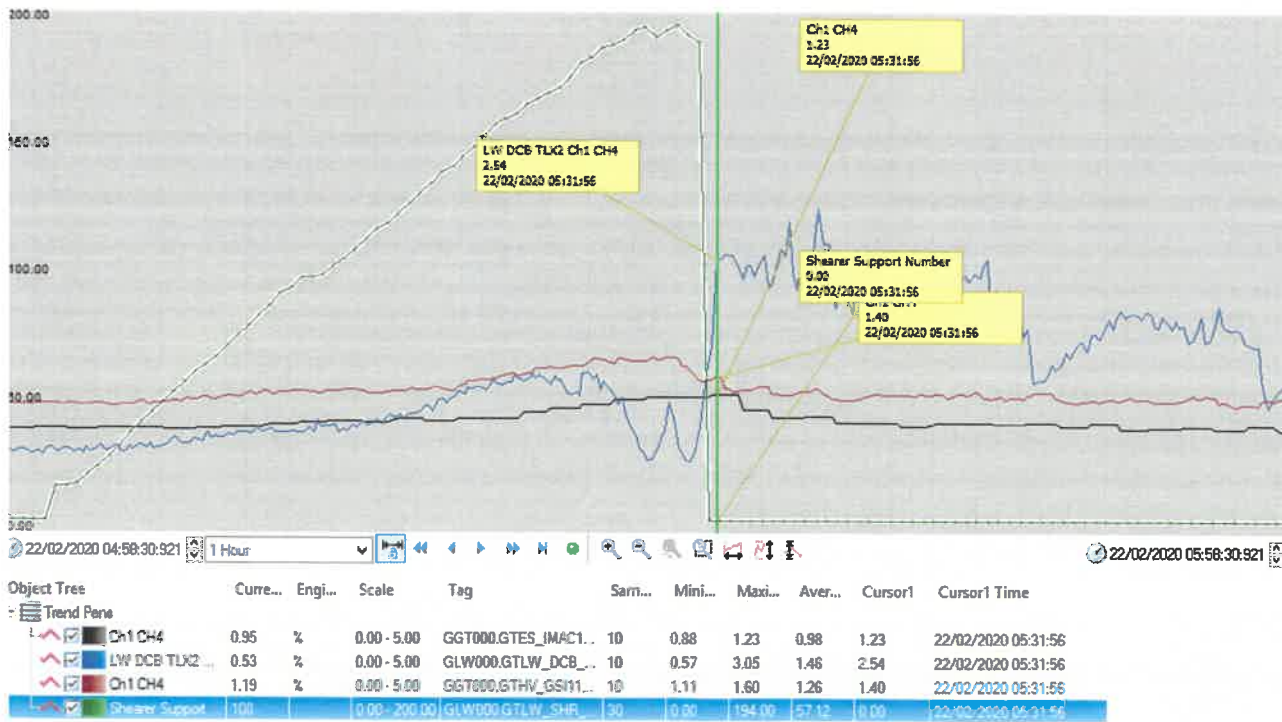
Figure 6. Shearer and CH4 monitor trending showing 0m Sensor CH4 concentrations exceeding (1st spike) 2.5% at 05:31:56

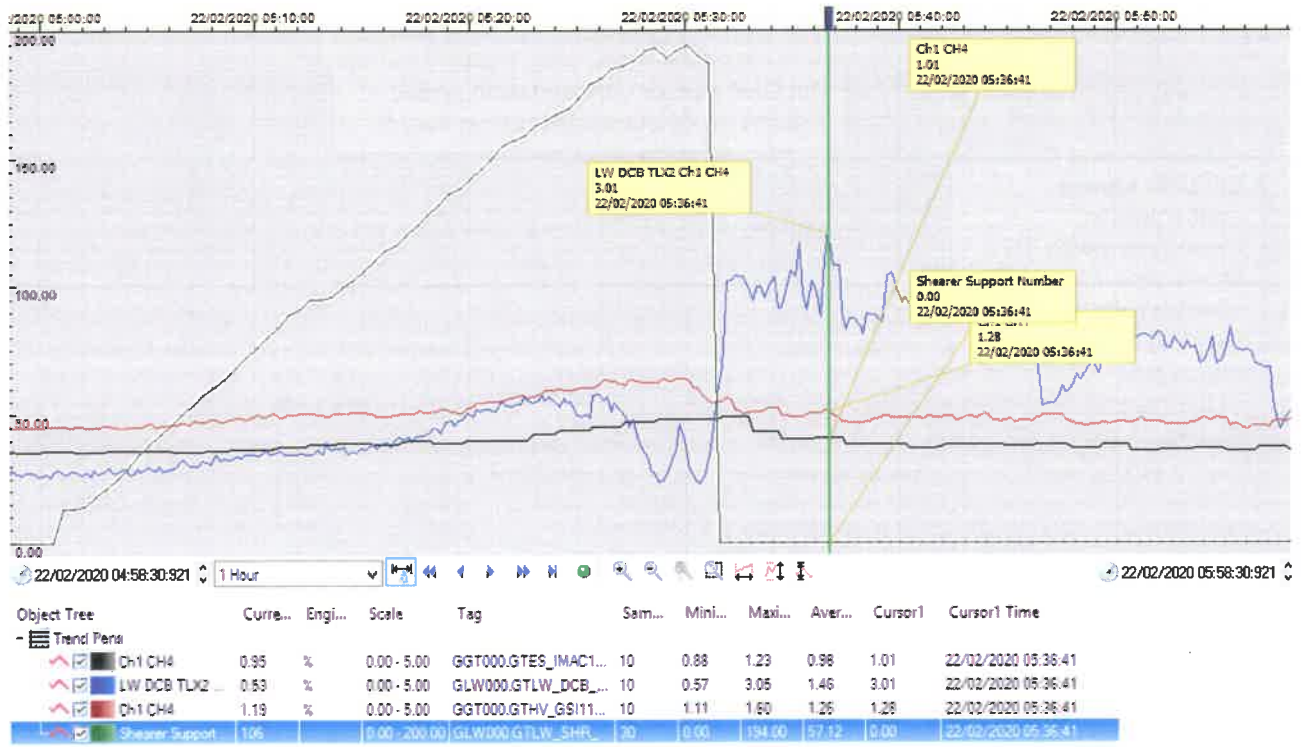
Figure 7. Shearer and CH4 monitor trending showing 0m Sensor CH4 concentrations reaching peak of 3.01% at 05:36:41

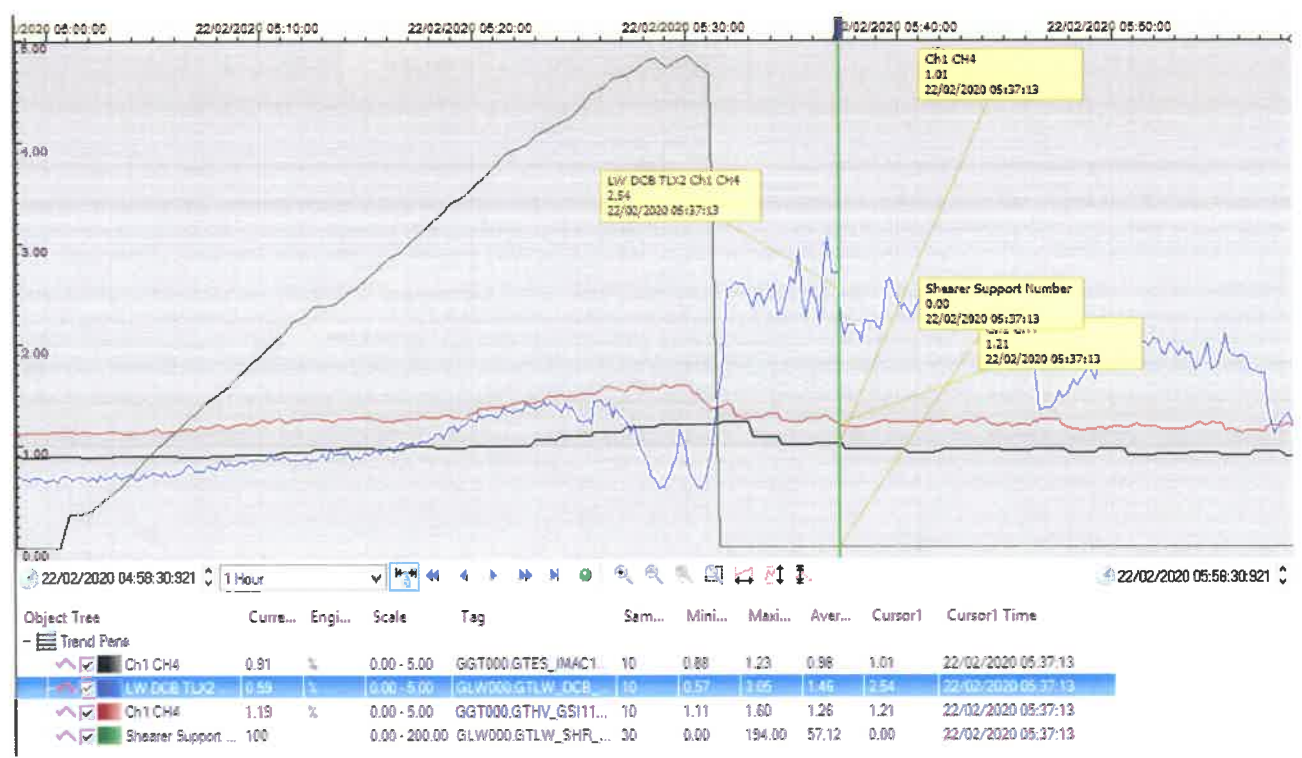
Figure 8. Shearer and CH4 monitor trending showing 0m Sensor CH4 concentrations reduce (1st spike) below 2.5% at 05:37:13

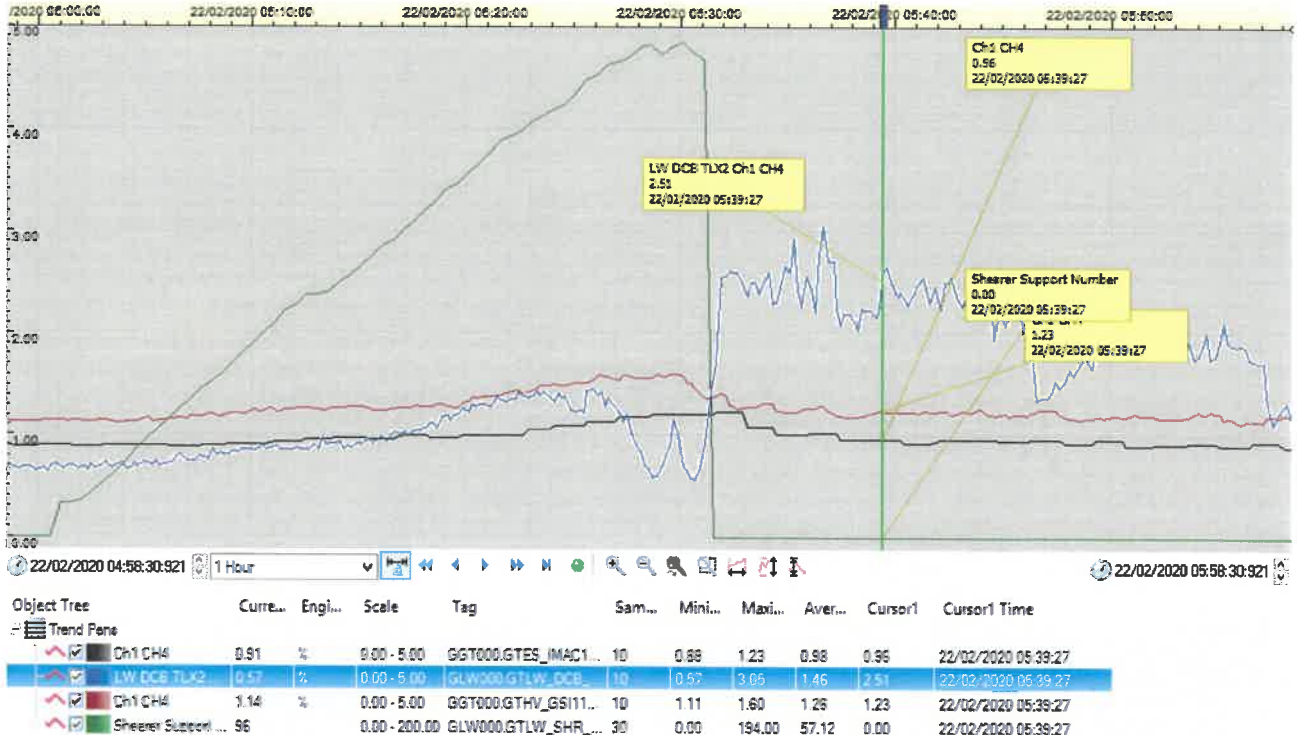
Figure 9. Shearer and CH4 monitor trending showing 0m Sensor CH4 concentrations again (2nd spike) exceeding 2.5% at 05:39:27

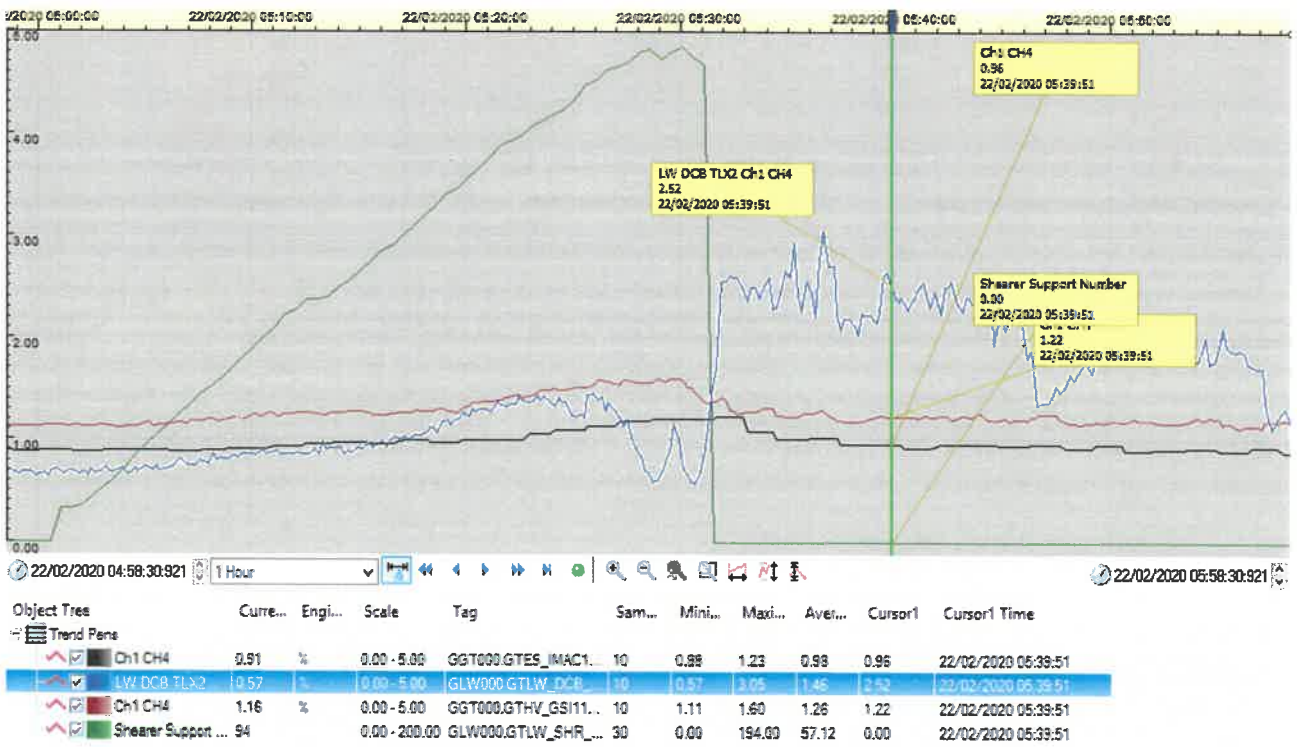
Figure 10. Shearer and CH4 monitor trending showing 0m Sensor CH4 concentrations reduce (2nd spike) to below 2.5% at 05:39:51

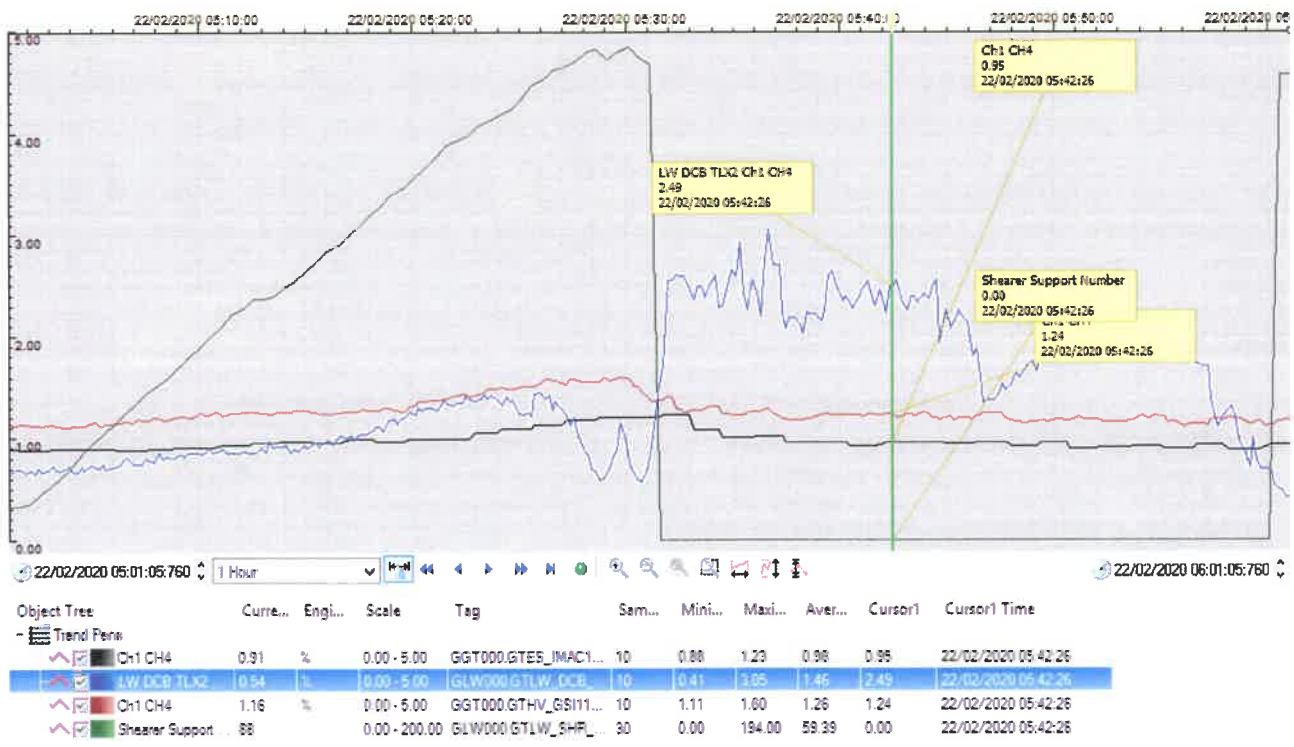
Figure 11. Shearer and CH4 monitor trending showing 0m Sensor CH4 concentrations again (3rd spike) exceeding 2.5% at 05:42:26

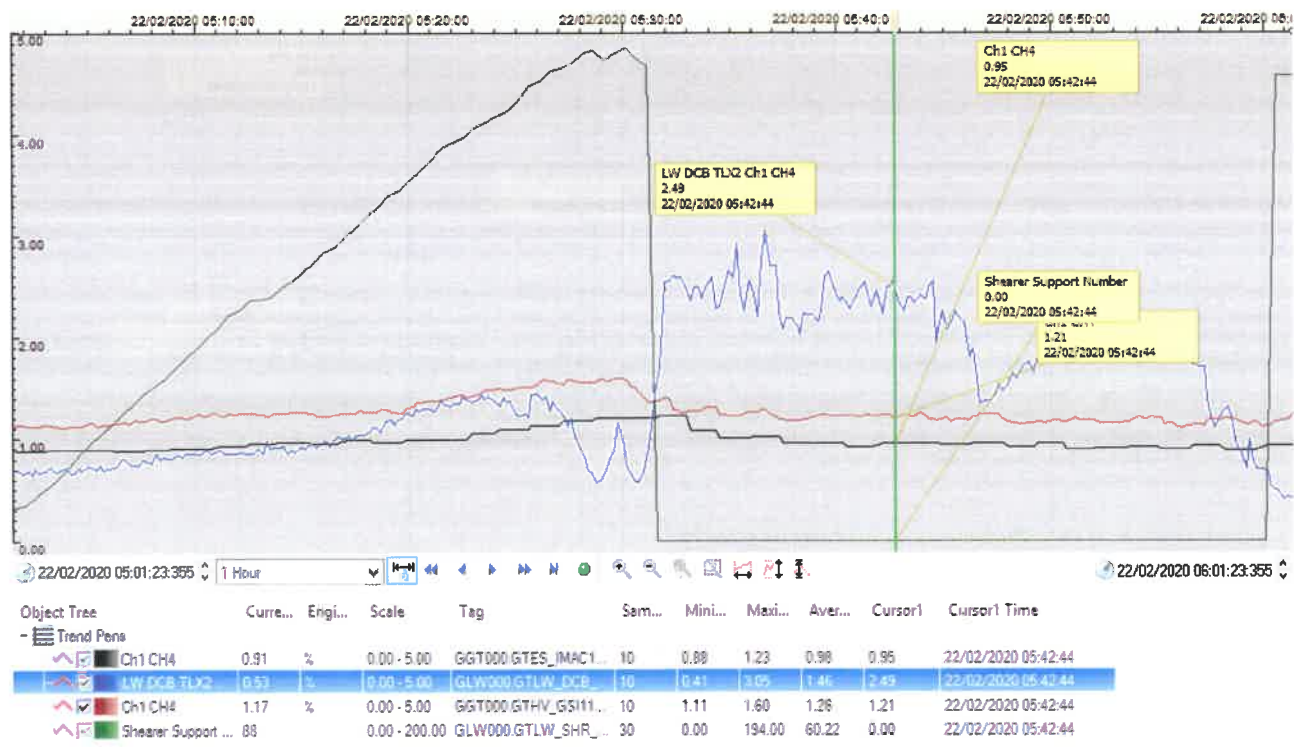
Figure 12. Shearer and CH4 monitor trending showing 0m Sensor CH4 concentrations reduce (3rd spike) below 2.5% at 05:42:44

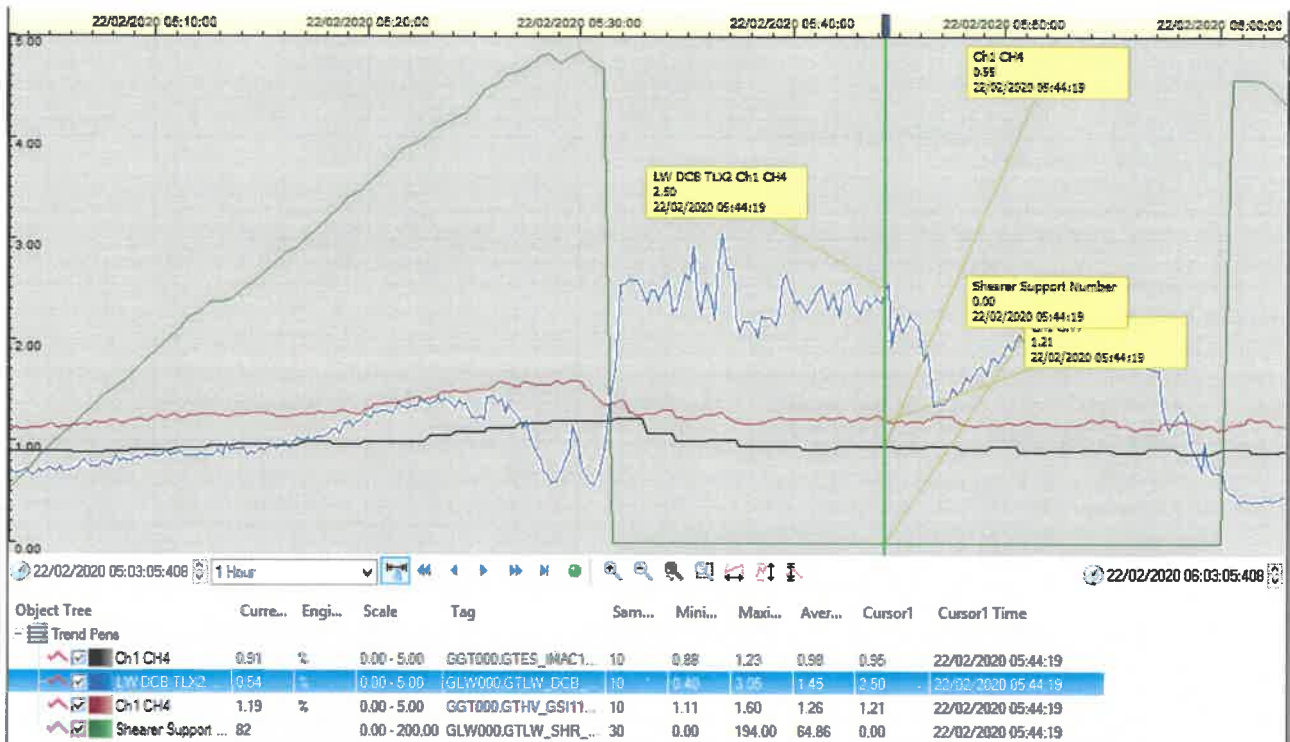
Figure 13. Shearer and CH4 monitor trending showing 0m Sensor CH4 concentrations again (4th spike) exceeding 2.5% at 05:44:19

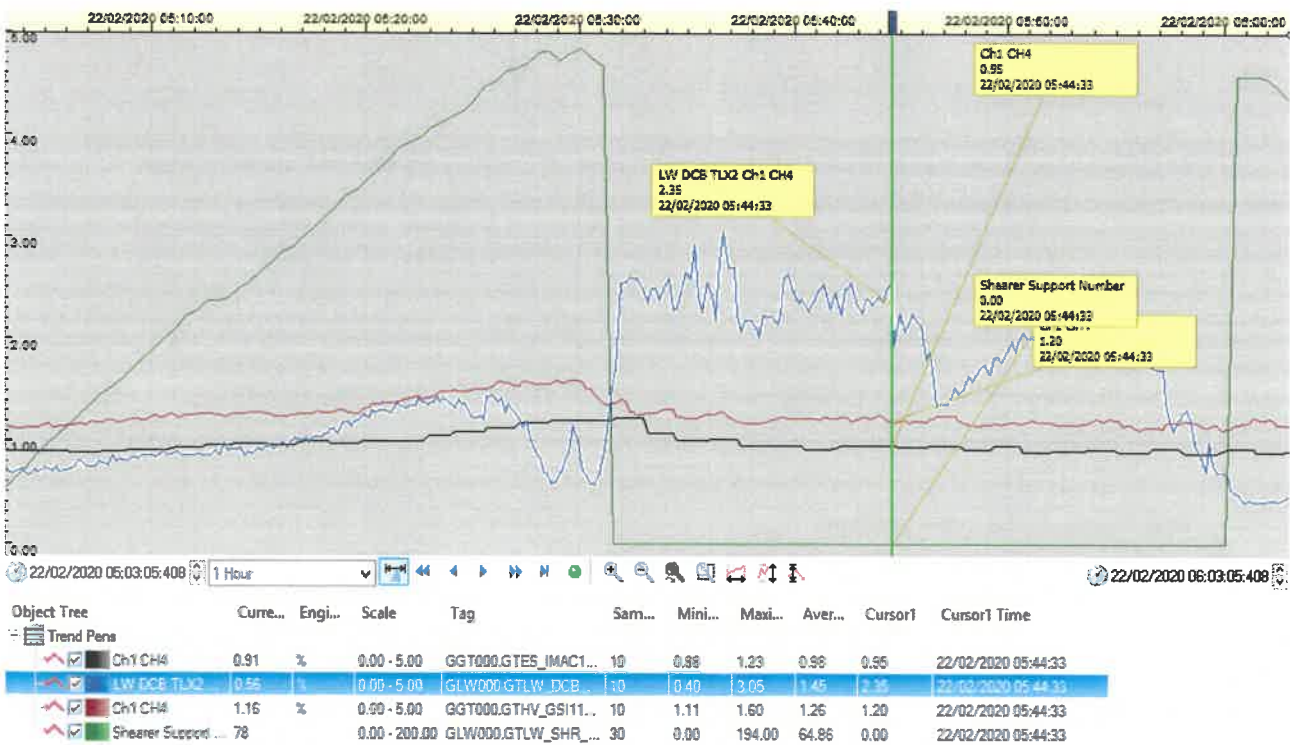
Figure 14. Shearer and CH4 monitor trending showing 0m Sensor CH4 concentrations reduce (4th spike) below 2.5% at 05:44:33
