INVESTIGATION REPORT

GRASSTREE MINE

Incident Number: IN.00216236

Incident Title: >2.5% CH4 LW808 TG Flushing

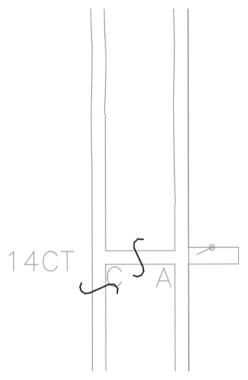
Location of 808TG Stub at 14CT (intersected by the face at time of incident).

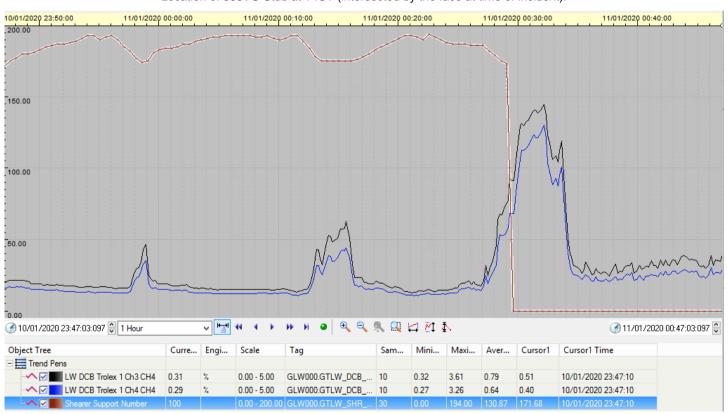
When cutting into the tailgate, on approach to intersecting the drill stub, an additional advance (push) of the face was undertaken (3x pushes, compared to 2x pushes in typical operation). This additional advance was undertaken in order to try and catch the lip of the drill stub in the tailgate with the face supports to ensure the integrity of the tailgate area (as in the prior 200m of retreat tailgate conditions had been heavy at times). During each face advance, methane spikes were recorded at the tailgate drive sensors (at escalating concentrations).

TG Drive Methane Sensor data with Shearer position showing methane spikes with each push of face at the TG

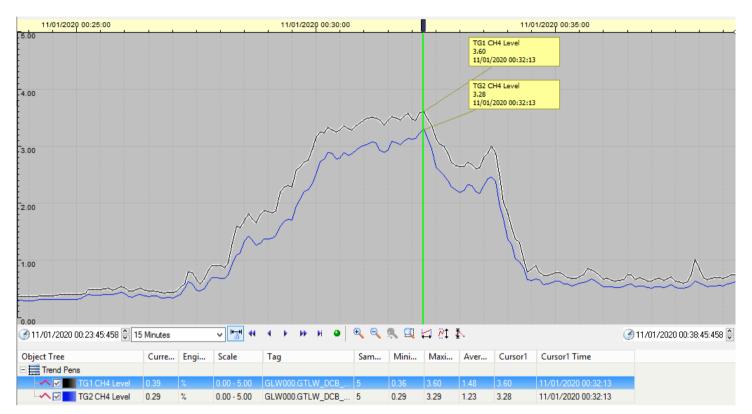
During the third push, at 00:29hrs 11/1/20 the roof immediately behind the tailgate goafed forcing a concentrated volume of goaf atmosphere to be pushed over the tailgate drive methane sensors resulting in methane reaching 2.5%, peaking at 3.6% at 00:32hrs then returning below 2.5% at approximately 00:33hrs (total duration >2.5% CH4 – Approximately 4minutes). This event tripped face power.

TG Drive Methane Sensor data during >2.5% event showing peak of 3.6% at 00:32:13
