# METHANE EXCEEDANCE TG604

Moranbah North Mine  
June 2020

# HPI SUMMARY

## Executive Summary from LFI report

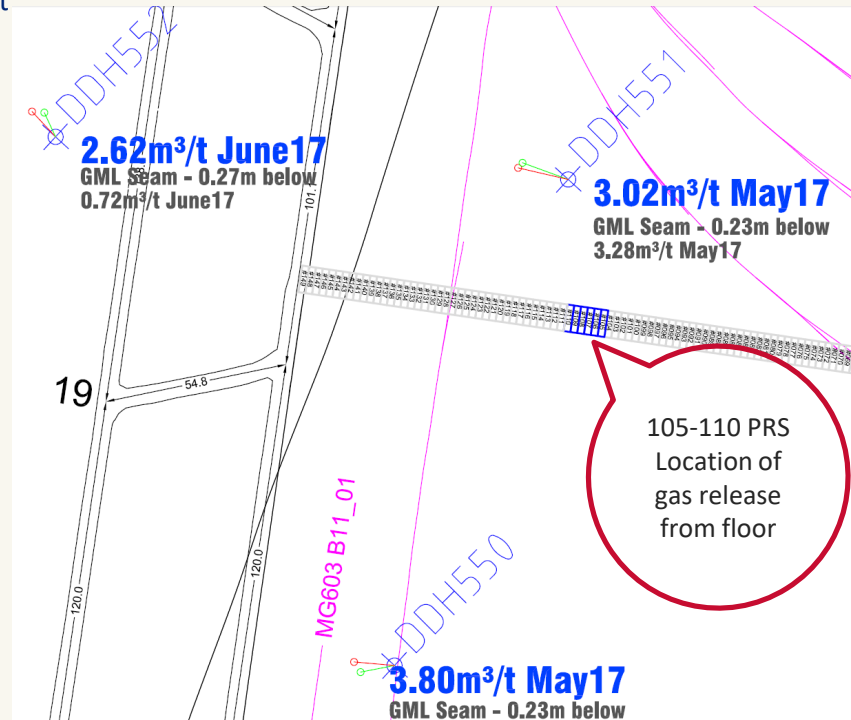
- The Longwall was at 2404m chainage at the time of the gas event
- There was 72m<sup>3</sup>/s ventilation across the longwall face.
- SO670A goaf well was in standby mode due to high oxygen

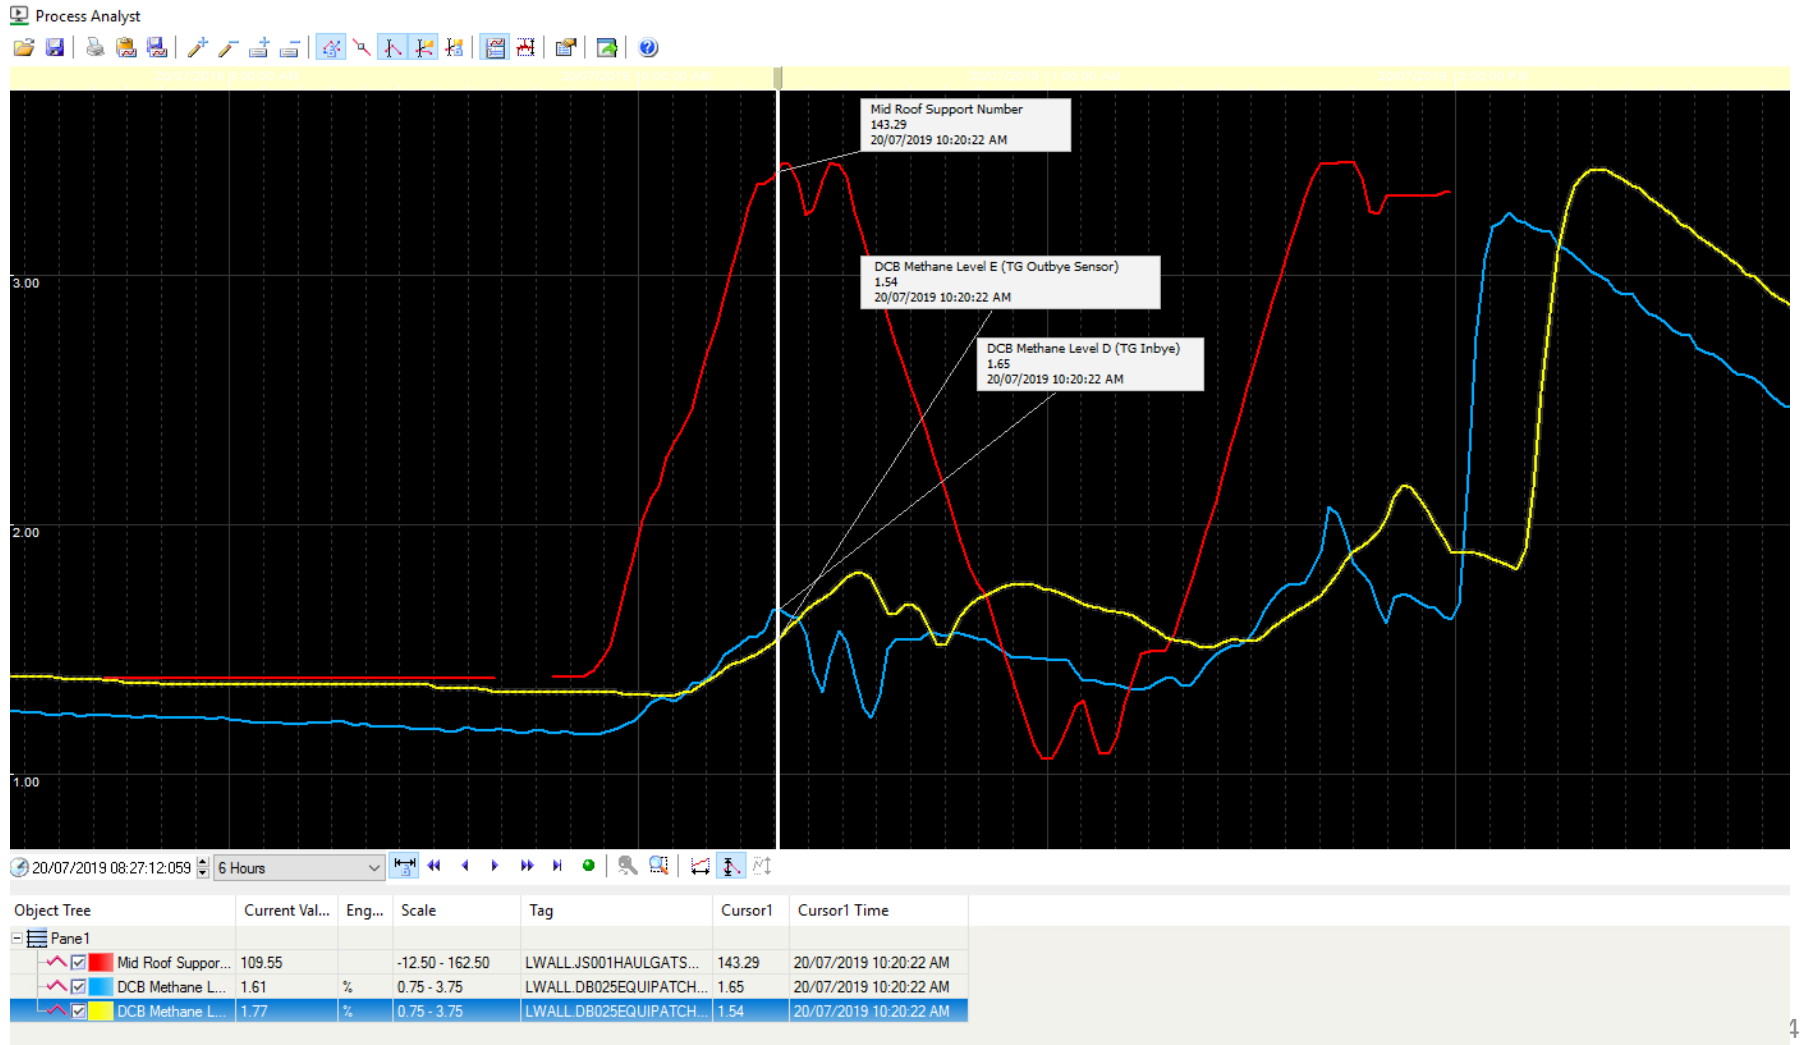
- First shear of the shift the TG IB sensor peaks at 1.65% methane

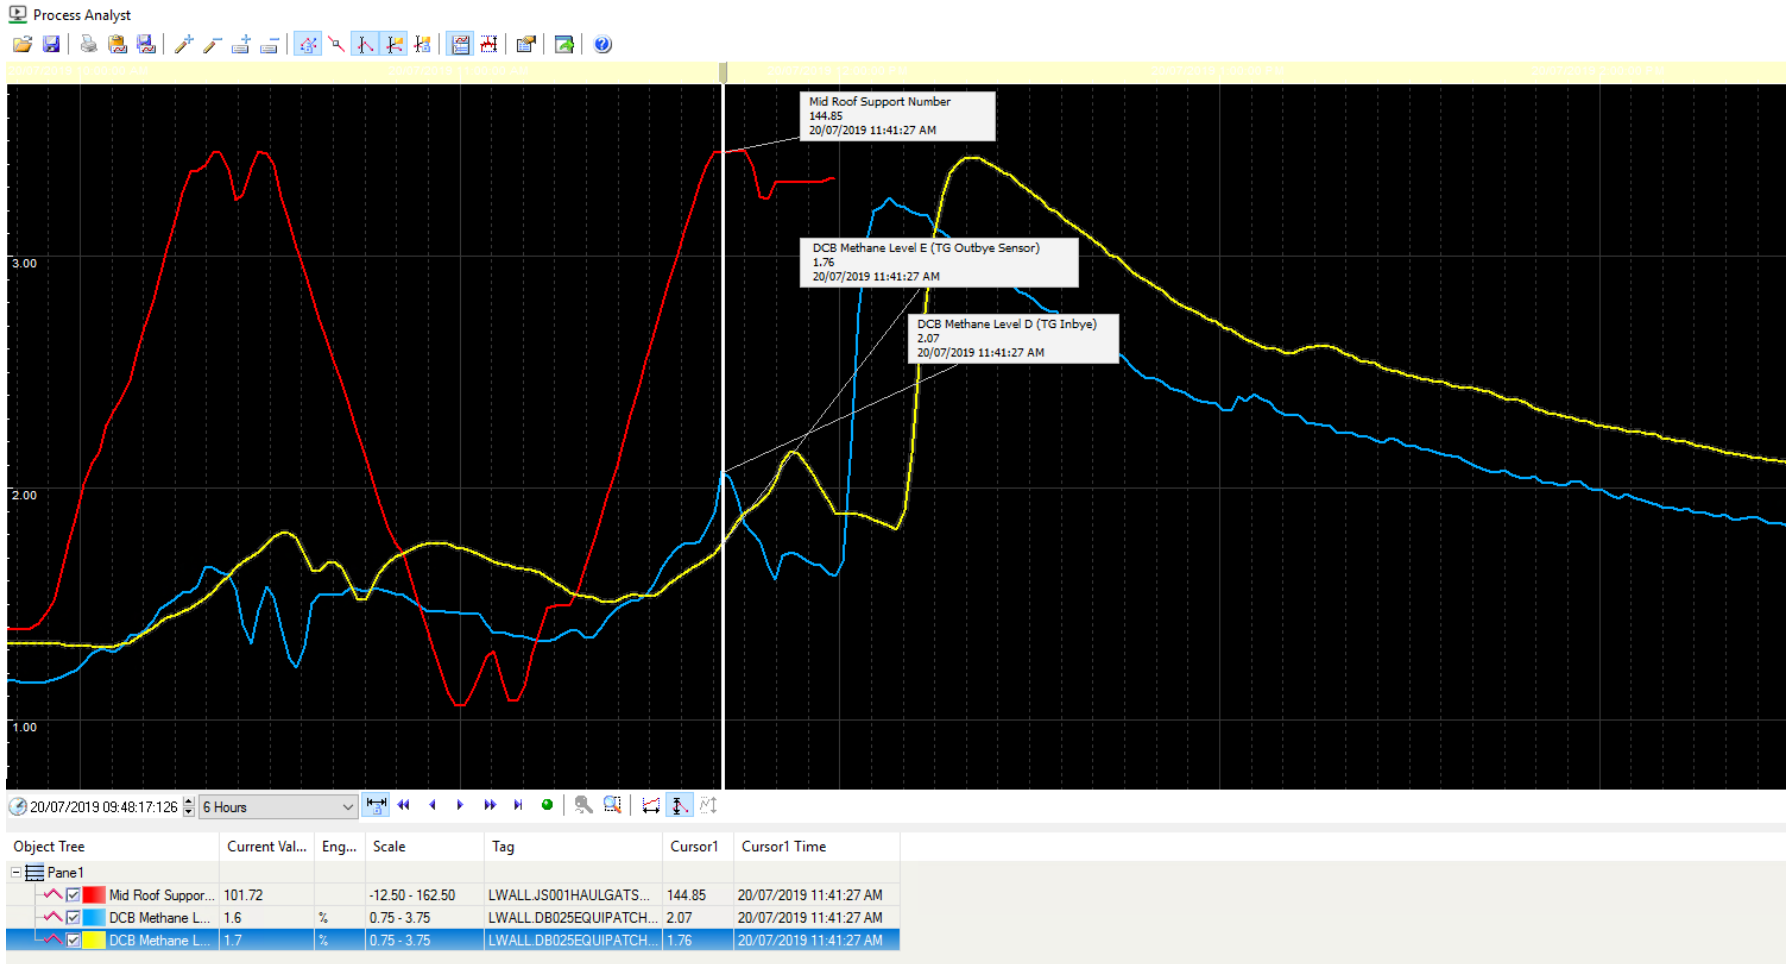
- The second shear the shearer flush raises the level at the TG IB sensor to a peak of 2.07% methane

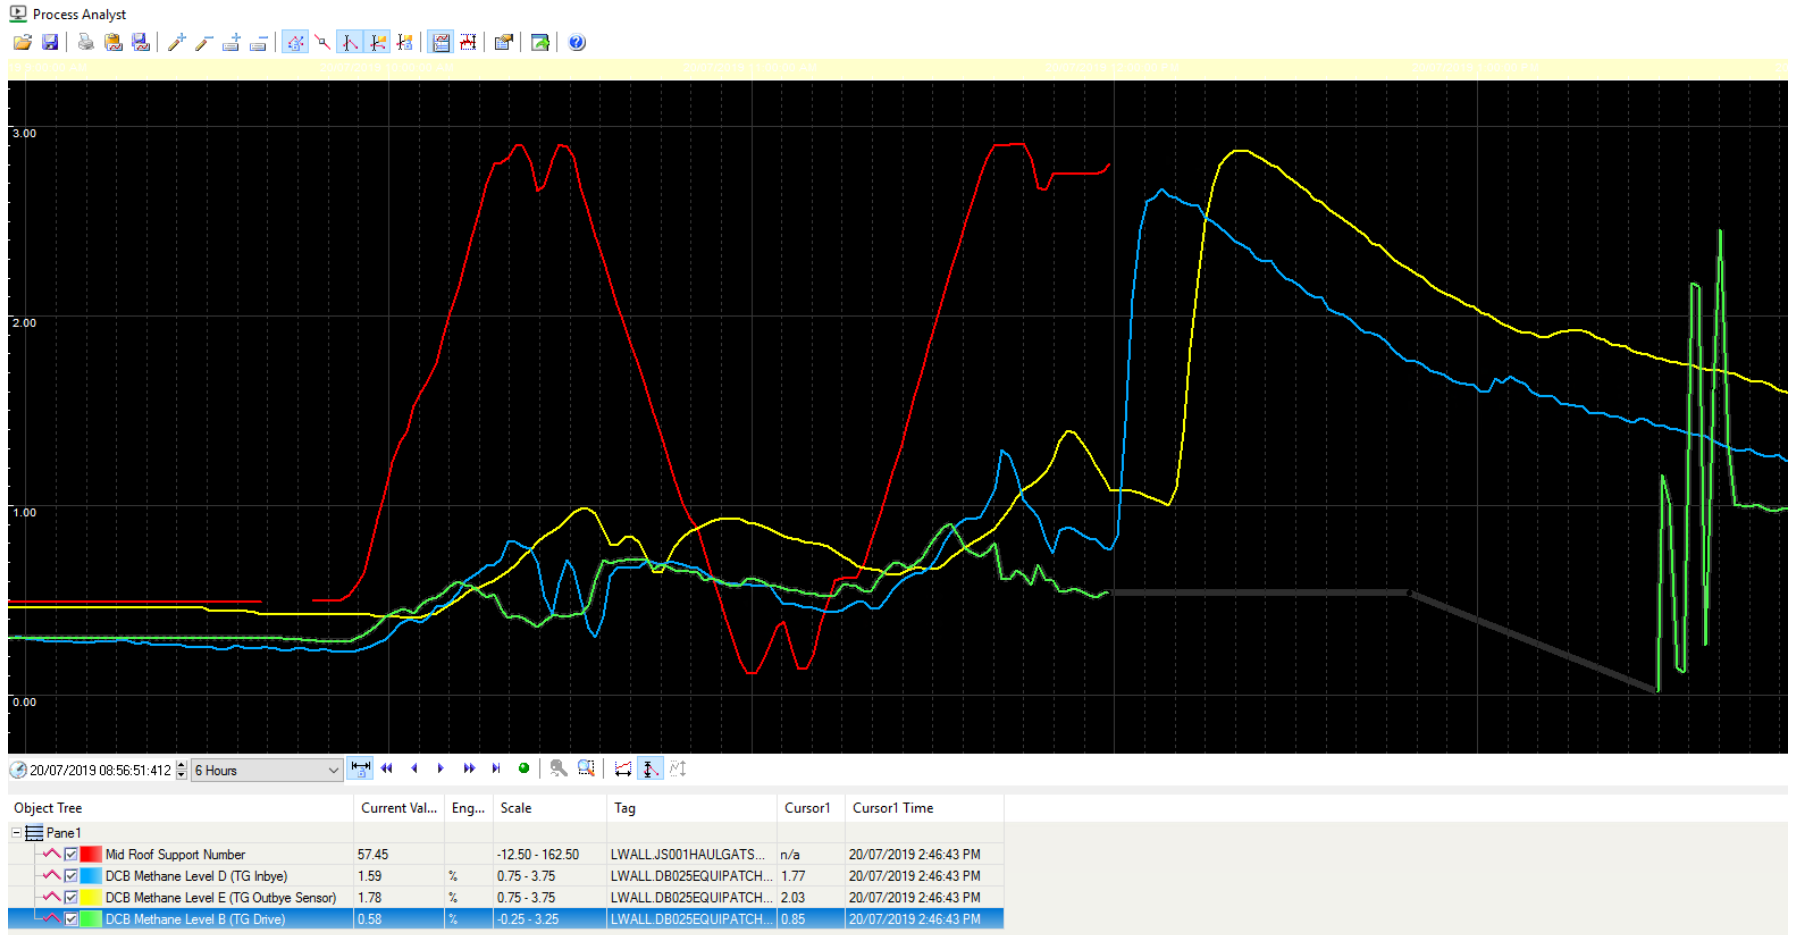
- At 11.59 am the floor gas releases. The TG drive sensor fails (Green)

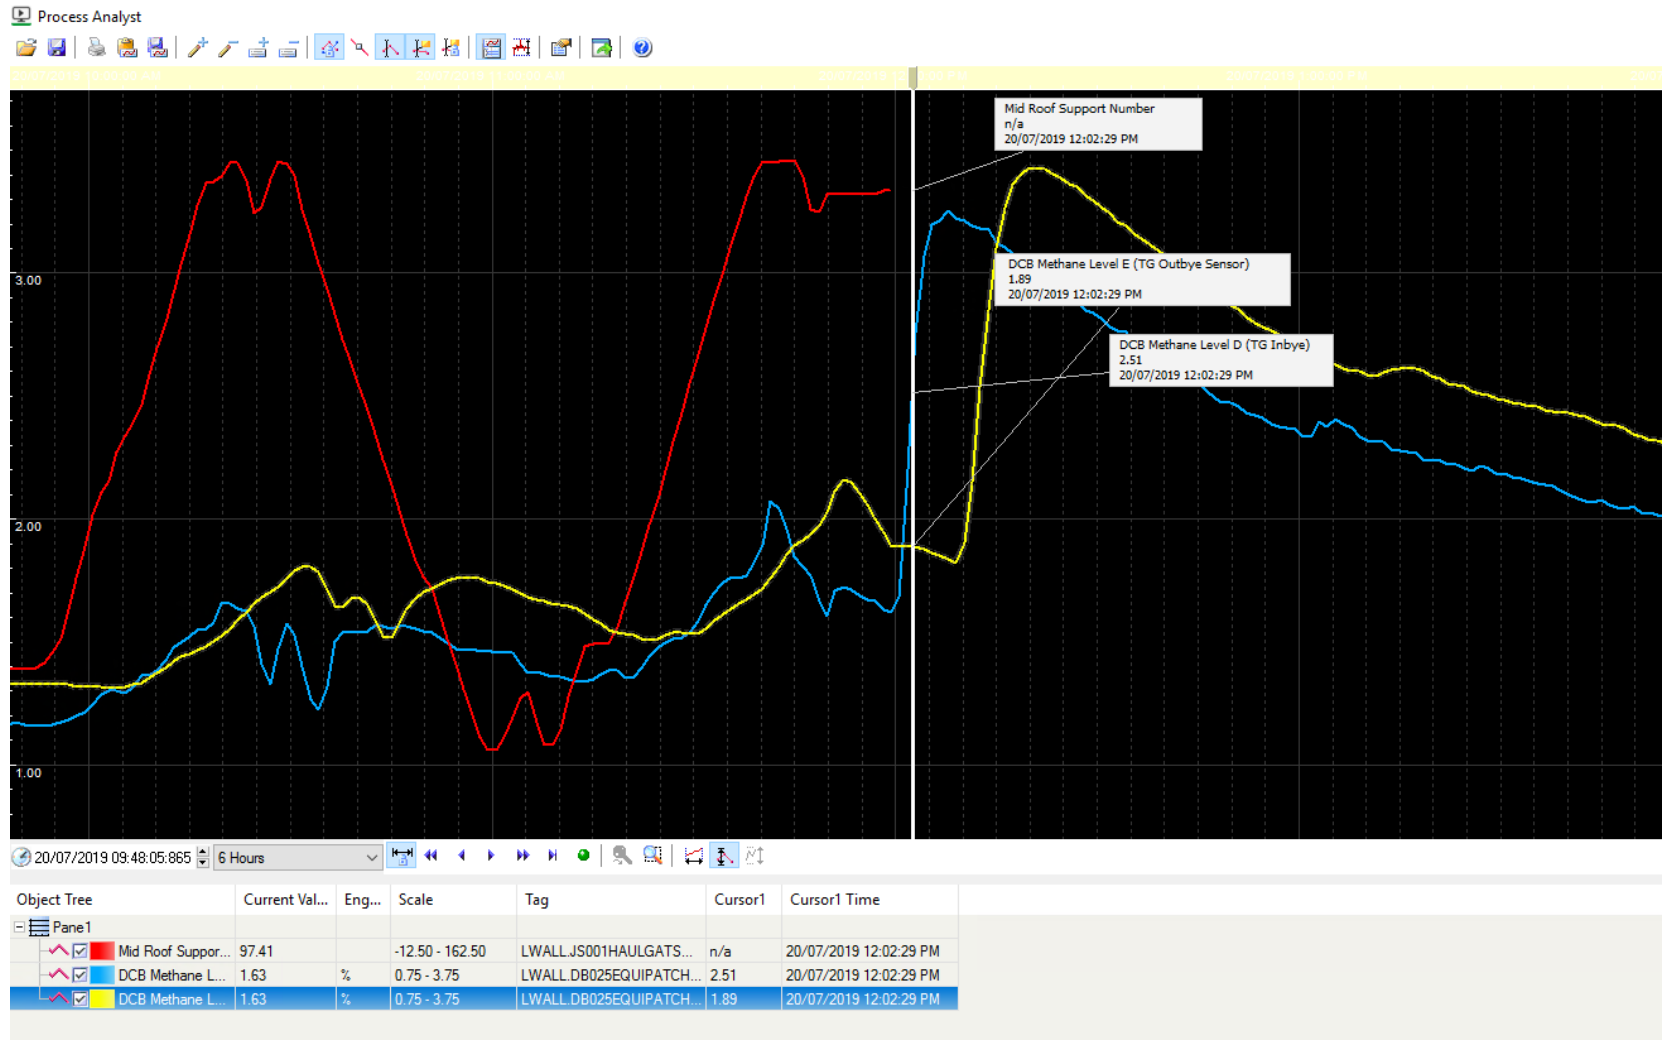
- The TG IB sensor sees the GB gas levels exceed 2.5% at 12.02 pm

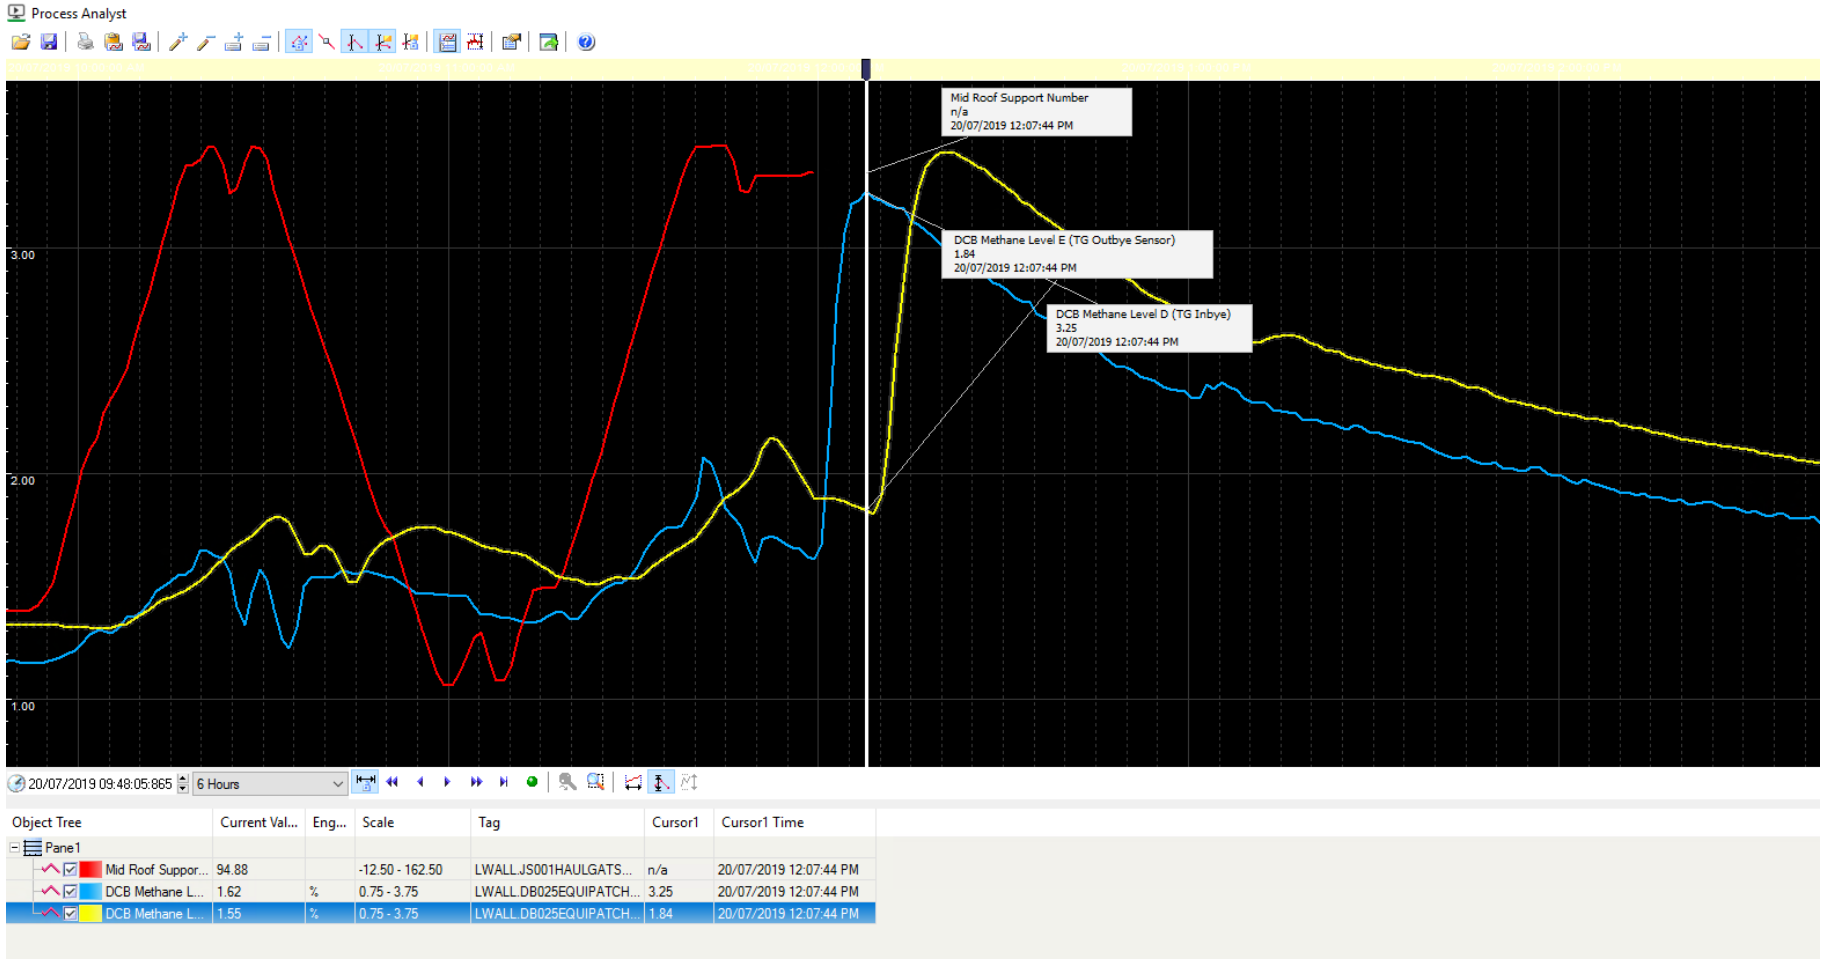
- 12:07 pm the TG IB sensor peaks at 3.25% CH4

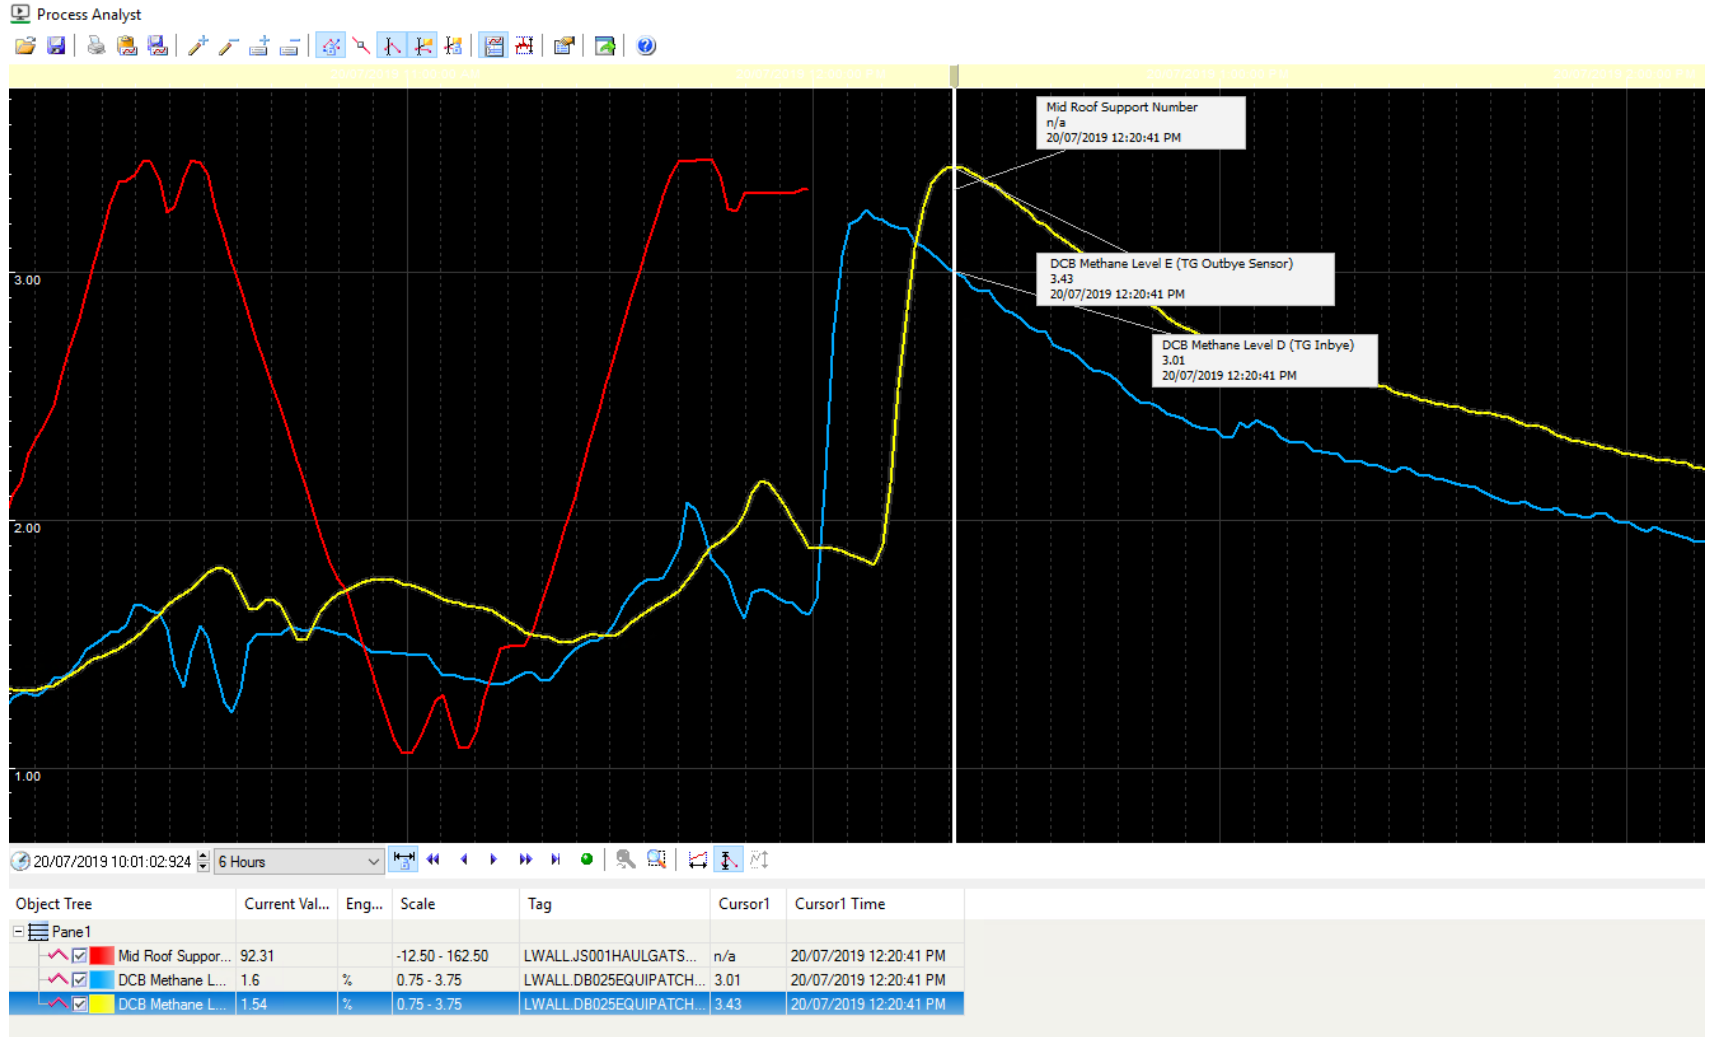
- 13 minutes later the TG OB sensor peaks at 3.43% CH4

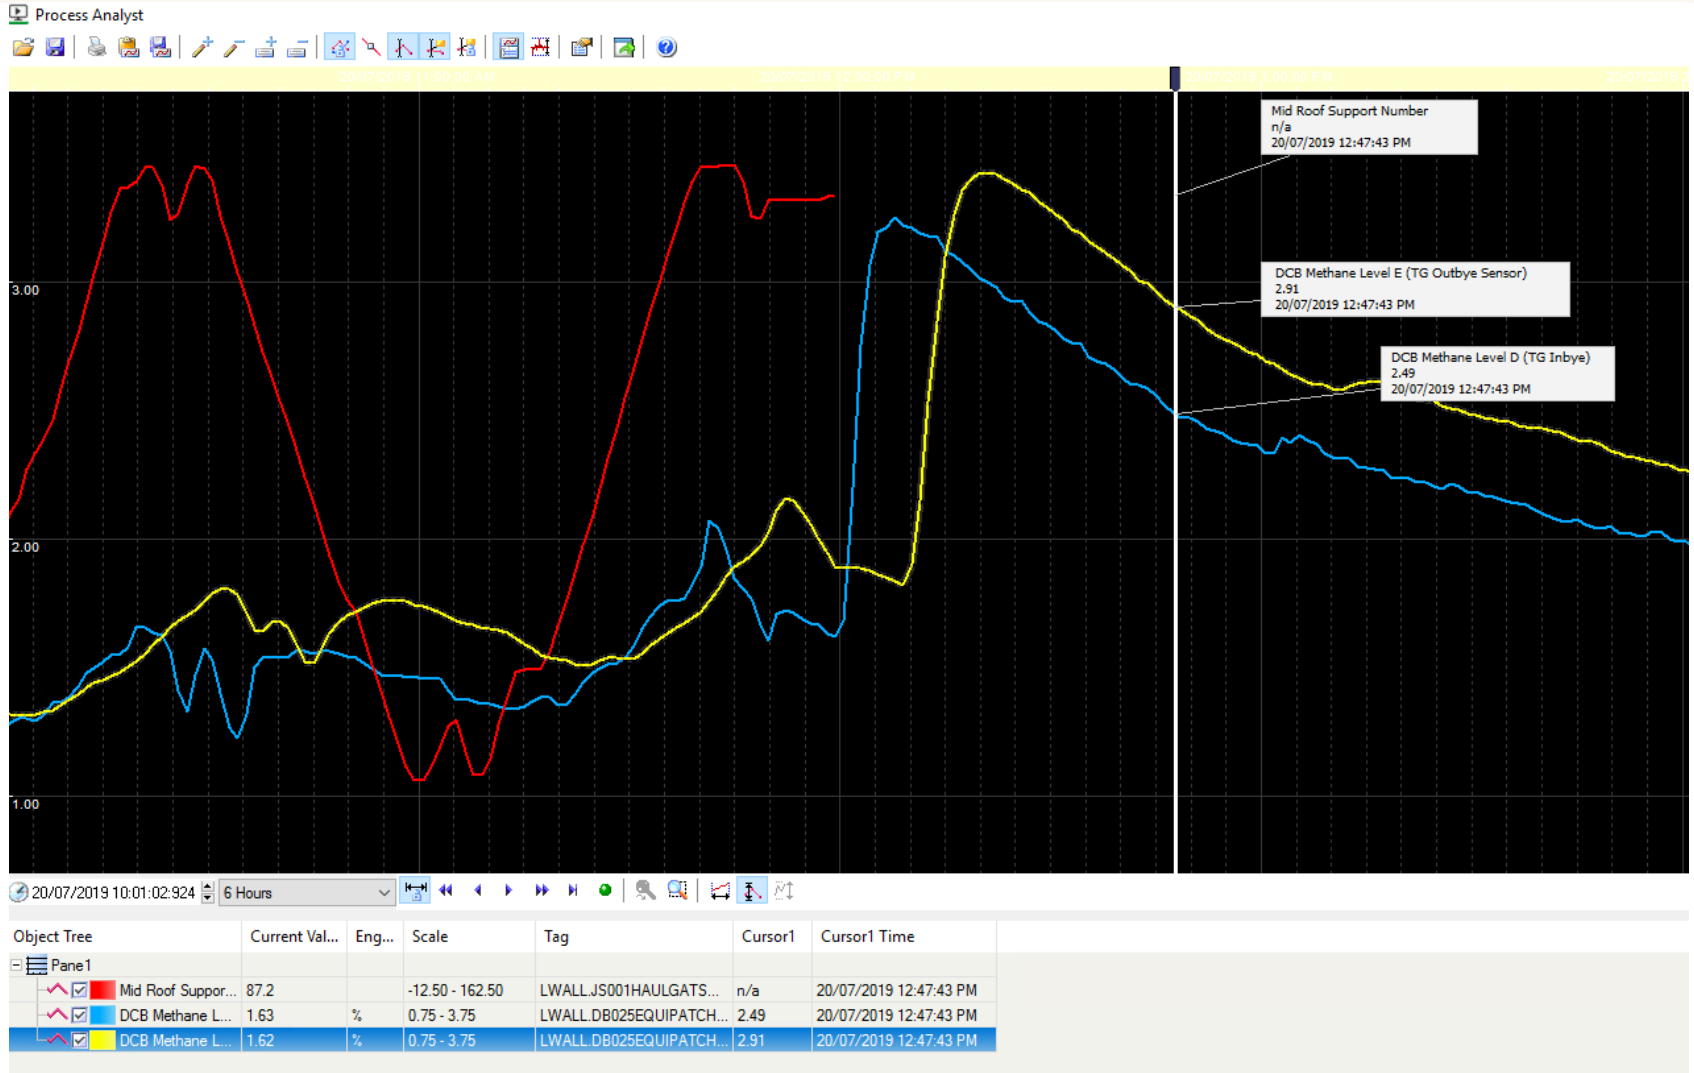
- 12:47 pm the IB sensor returns readings below 2.5% CH4 with the OB sensor following suit at 13:29.

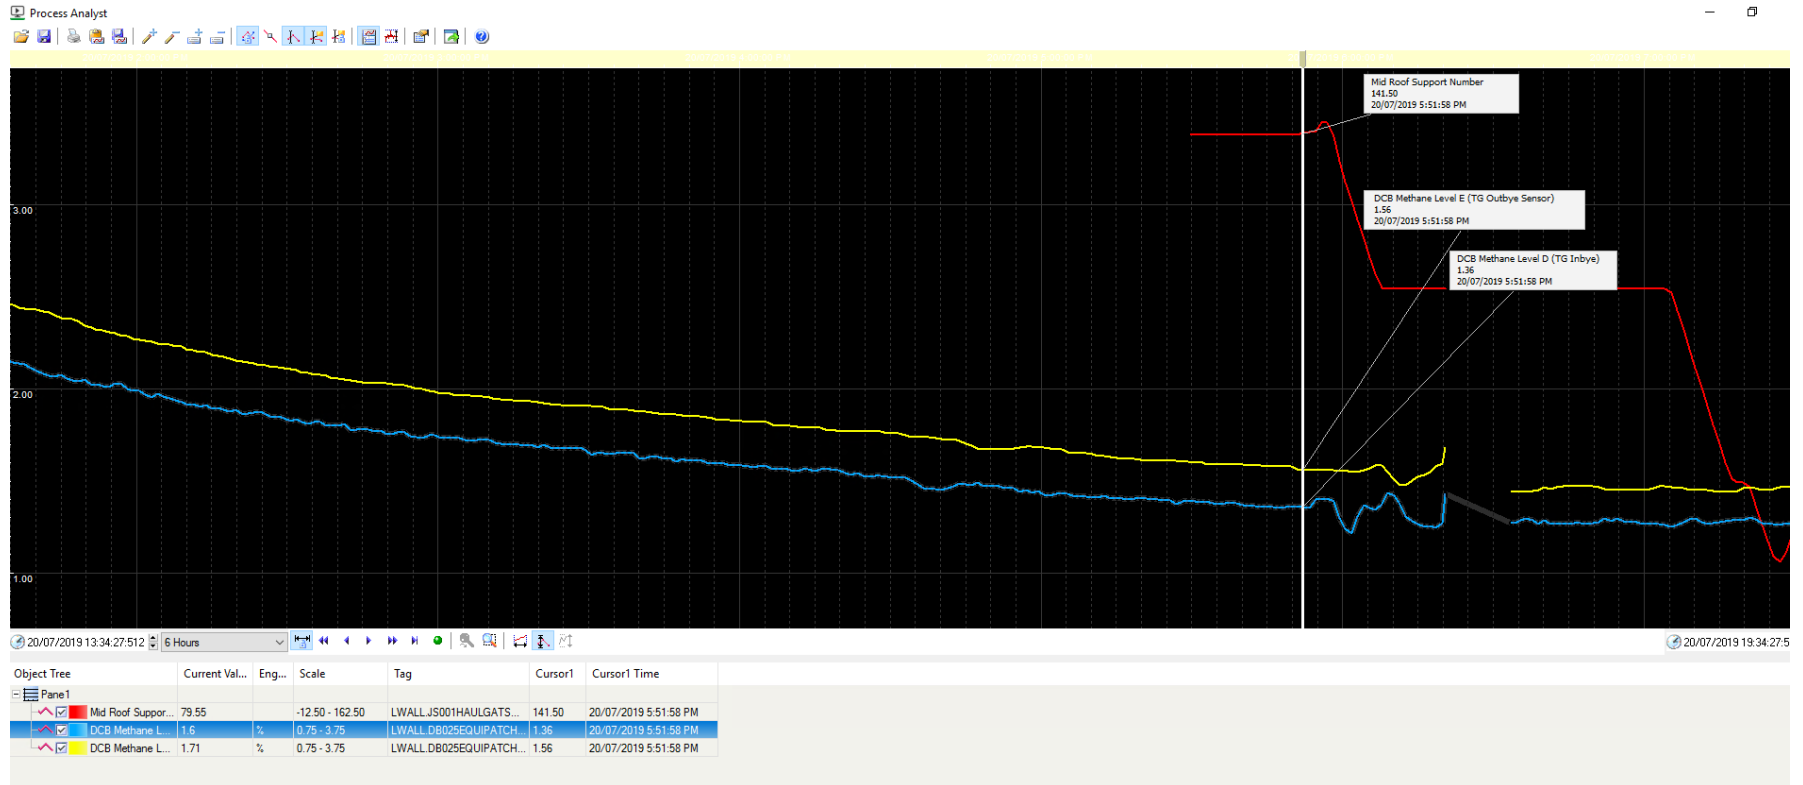
- Production resumes at 17:51 with TG CH4 levels having returned to normal at 1.36%

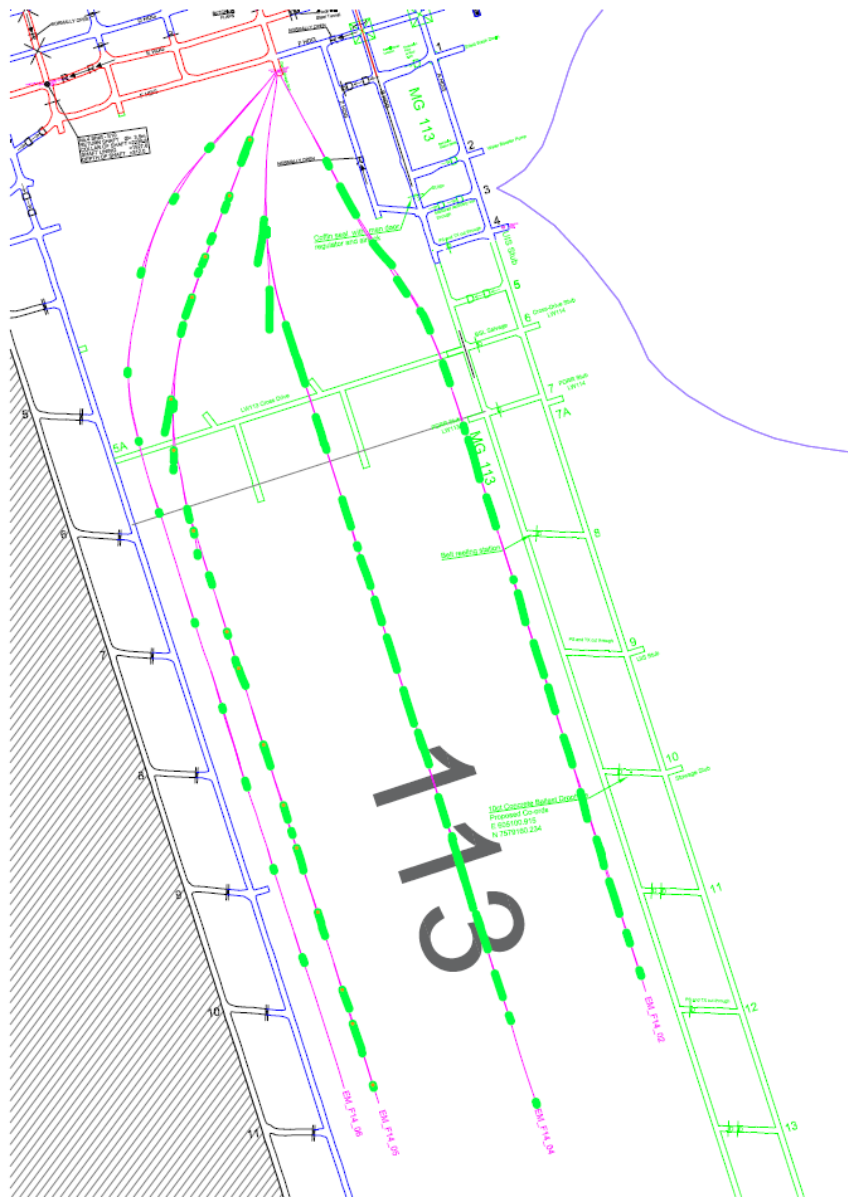
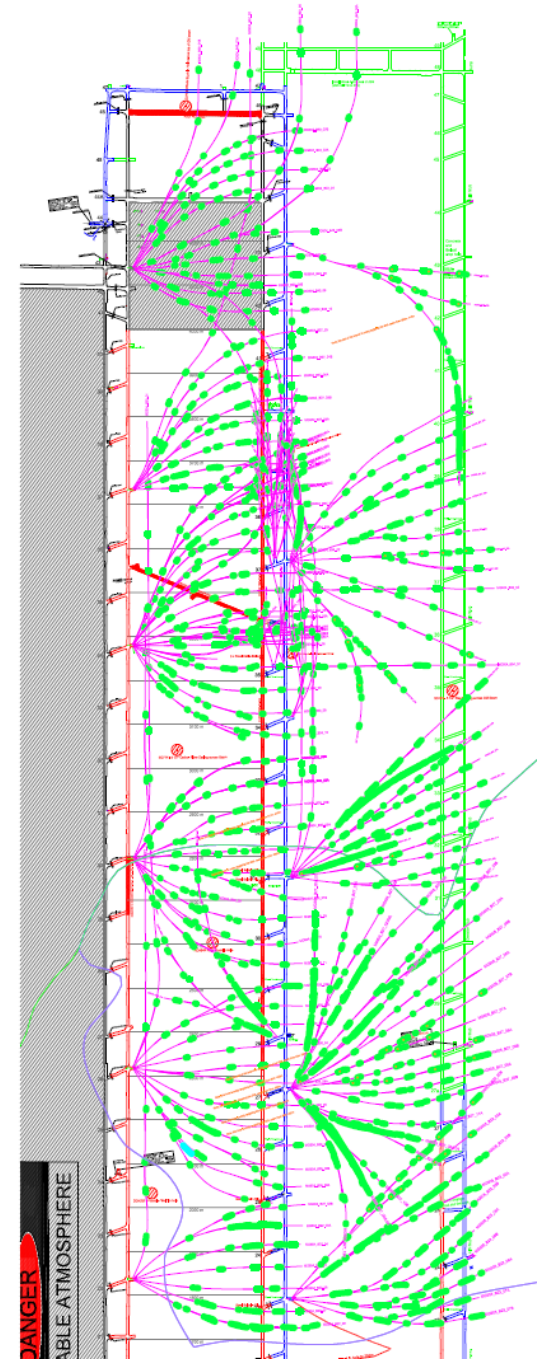
# ACTUAL GML DRAINAGE TO DATE

- The UIS GML floor touch strategy has effectively drained the GML in LW605 too ~ half the virgin content. Borehole Gas content test records illustrate the effectiveness of the drainage.
