GROSVENOR COAL MINE

TEM-SMRT Meeting Minutes

Meeting Minutes	**LW104 CH 4002**		
Date / Time	02/05/20 14:30		
Location	Tech Serv.		
Chairperson	Neil Bryan		
Attendees	**Name**		**Initial**
Undermanager	Neil Bryan		NB
Mine Geologist	James McGuiness		JM
LW Mining Co-Ordinator	Mick Copeland		MC
Roster Geotech.	Ed Steed		ES
Undermanager	Adam Kruse		BC
VO	Mark Johnston		MJ
Apologies			
-			
File Location	W:\Technical Services\Shared_LW104\11. IMT Minutes\SMRT\		
Minutes Taken / Updated by	James McGuiness		
Objective	Review conditions and determine a plan for going forward

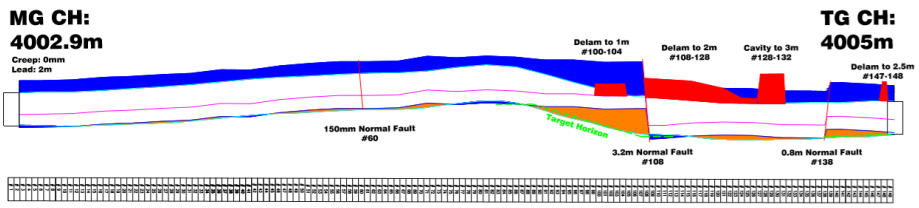
Ref	Description	Owner	Due date
1.0 Background Information			
	• 3.2m Normal Fault #108, 0.8m Normal Fault #138 • Delamination mostly 0.5-1m and increasing to top of seam in parts through large area, #97-132 • TTF good, mostly 1m and able to knuckle up, up to 1.5m in parts. • Probable low angle, face parallel shear extending from TG in combination with two faults, and proximity to turnaround, creating wide spread delamination • Additional cavity to top of seam 147-149, TG goaf normal, to rear #149 and rill around 3 cans visible into goaf • Pre-consolidation in TG from Ch4001 – 3989 • Slow retreat due to gas and maintenance window last 24hr. LONGWALL 104 FACE PROFILE

Ref	Description	Owner	Due date
2.0 Discussion Points			
	• Interaction of structures • Option of extending consolidation to TG • DSI previously mobilised, gear in position		
3.0 Plan Moving Forward			
	• PUR 97 – 132, 4.5m up holes (C) • Fill 112-116 • Review opportunities for TG PCB installation work		
Next Meeting date / Time	**As required**
