**INVESTIGATION REPORT – SECTION 201  
COAL MINING SAFETY AND HEALTH ACT 1999  
GROSVENOR MINE  
Metallurgical Coal**

**Incident Number: IN.00226742 & IN.00228255**

**Incident Title: Withdrawal from Mine and Ignition of Gas  
LW104**

**Incident Date: 8 June 2020**

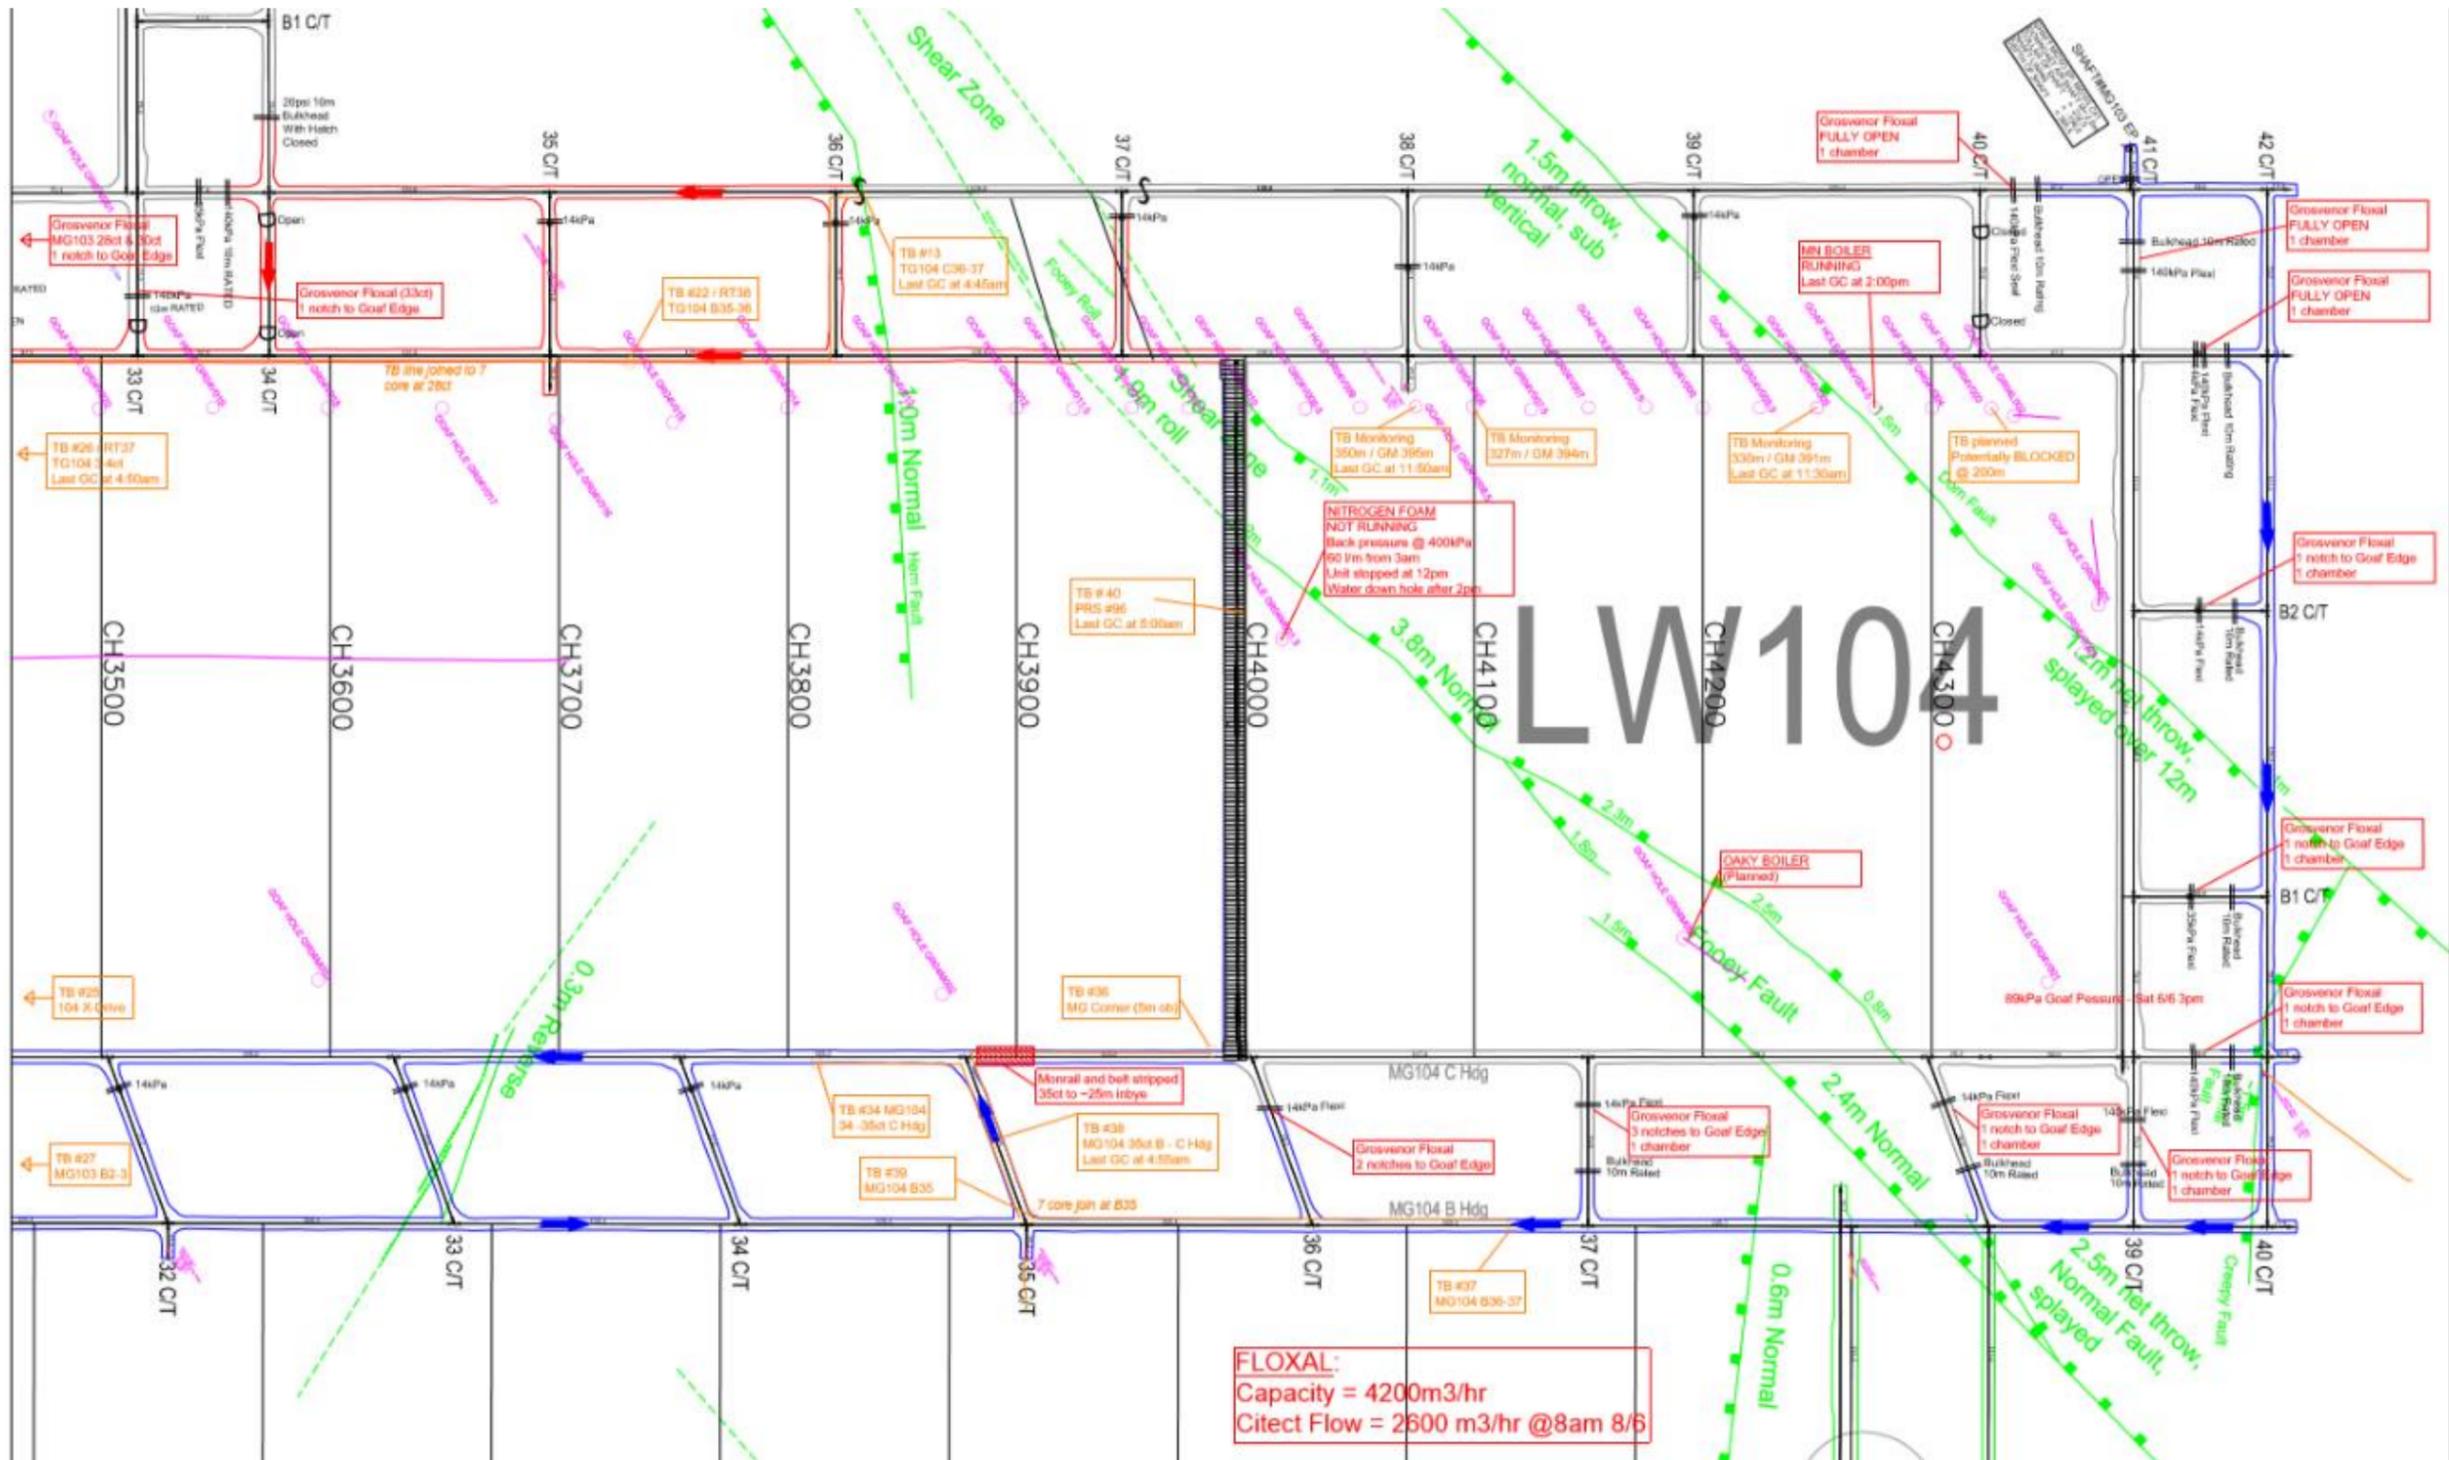
Figure 1: Sampling Locations (as at 8<sup>th</sup> June 2020)

Tube bundle (**TB**) sampling was undertaken to monitor the evolving spontaneous combustion event using the locations identified in Figure 1.

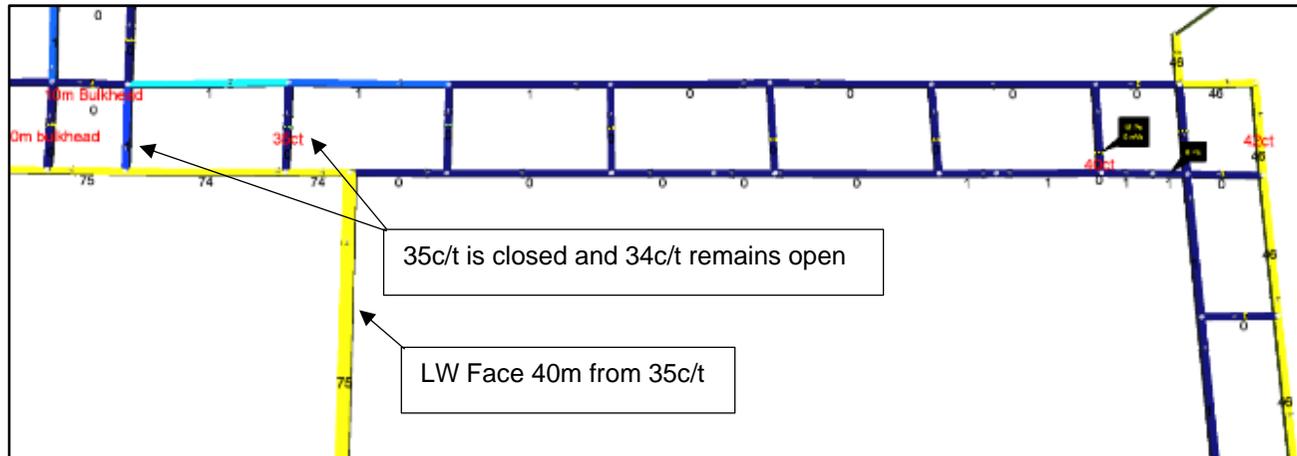
Figure 4 – LW Face is 40m from TG104 35ct

The above process is repeated until 36c/t. The final process is shown below.

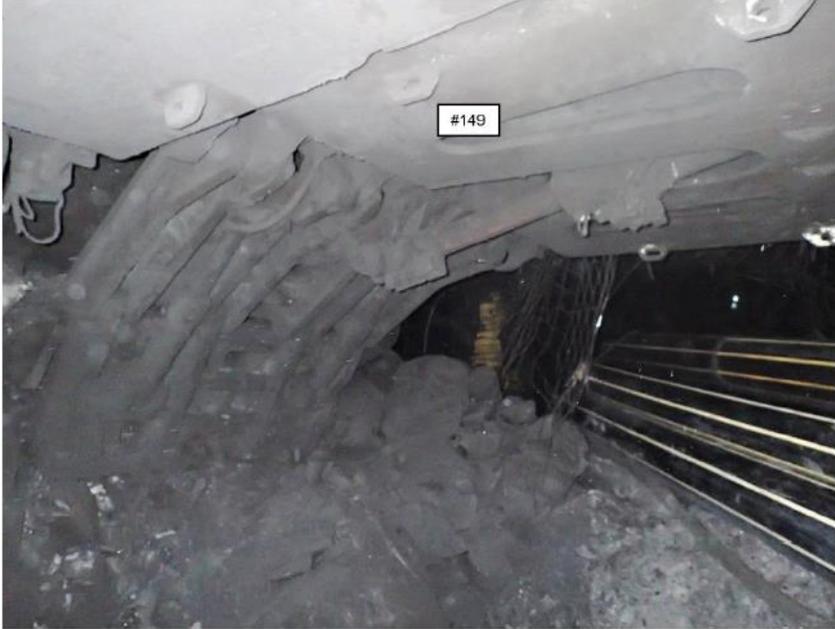
16 <sup>th</sup> May 2020	<p>Strata Risk Management Team formed due to deteriorating conditions in the TG roadway, triggering Level 2 LW Strata Control TARP. Notes on TG conditions (and photos from minutes):</p> <ul style="list-style-type: none"> <li>• Rill material located adjacent the TG shield is restricting access to the TG. Pipes set up adjacent to rill material</li> <li>• The TG corner is heavily deformed and broken</li> </ul>

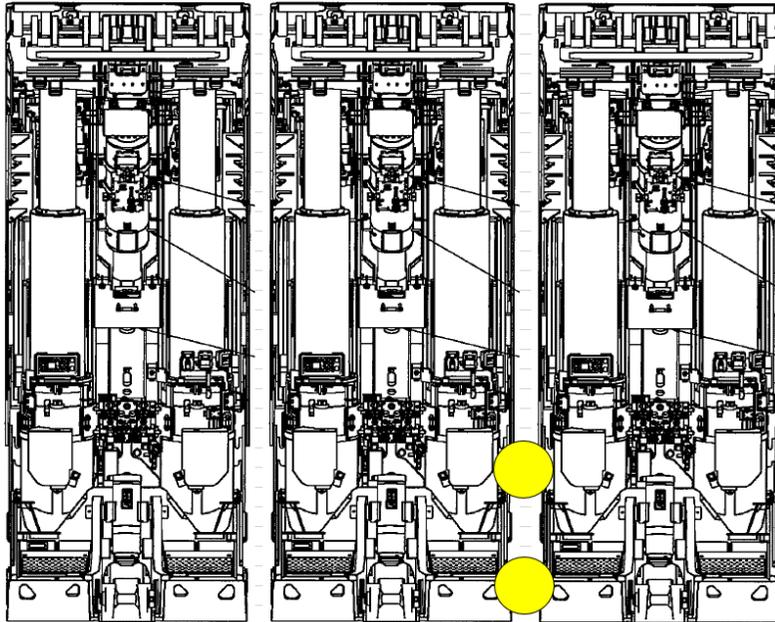
Location for temperature checks:

Implemented process for monitoring of LW104 faceline rear shield area for temperature and CO concentrations moving forward. These were recorded on a sheet and provided to the Undermanager each shift.

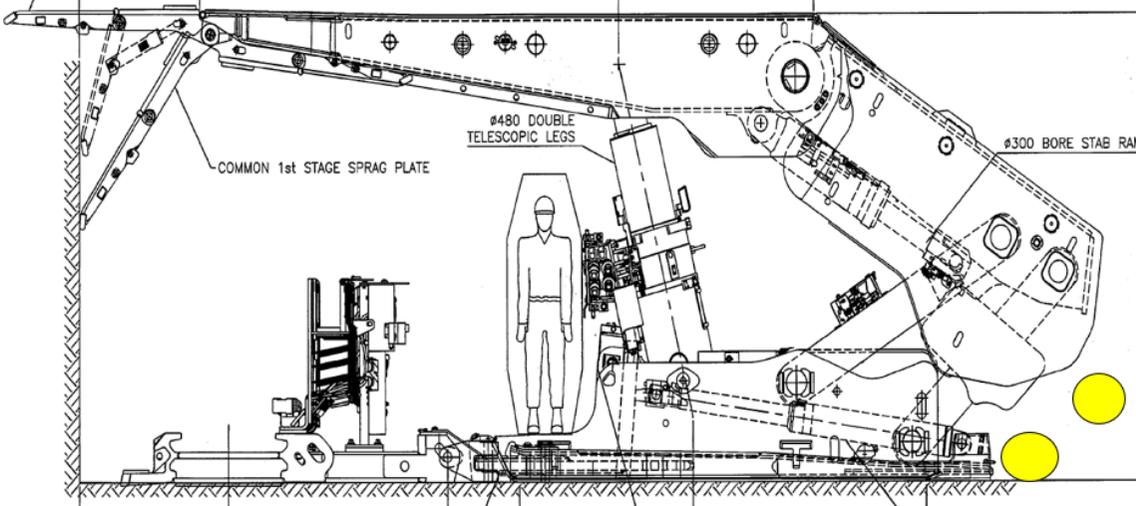
<p>Ongoing bag sampling around #96 shield implemented moving forward, due to this being identified as the highest temperature and CO concentration from first survey. Note – ERZ Controllers used MX-6 to determine the highest CO concentration in the rear walkway and then take a bag sample from that (using similar logic to taking a conventional goaf stream adjacent to the TG roof support). Bag samples sent to Joncris for trending and review hereafter.</p> <p>Dayshift ERZC marked bag sample location at #96 with information tag, with approval from DNRME inspector.</p> <p>The following options were identified for preparation of the longwall being stood for an extended period:  <u>Make C Hdg part of LW104 Active Goaf</u></p> <ul style="list-style-type: none"> <li>Option 1 - Install Flexi stopping C 36-37ct on outbye side of current brattice substantial stopping and inject from MG103 40-41ct C hdg Seal</li> <li>Option 2 - TG104 C HDG 34ct to 37ct installation of 140kpa seals, inertisation (extend from 34ct) and tube bundle monitoring (use TB#12 and TB #13 from TG Seals and extend to 34ct and 37ct)</li> </ul>
